**Department of
Environmental
Conservation**

Camp Santanoni Historic Area

Proposed Final Unit Management Plan

Town of Newcomb – Essex County

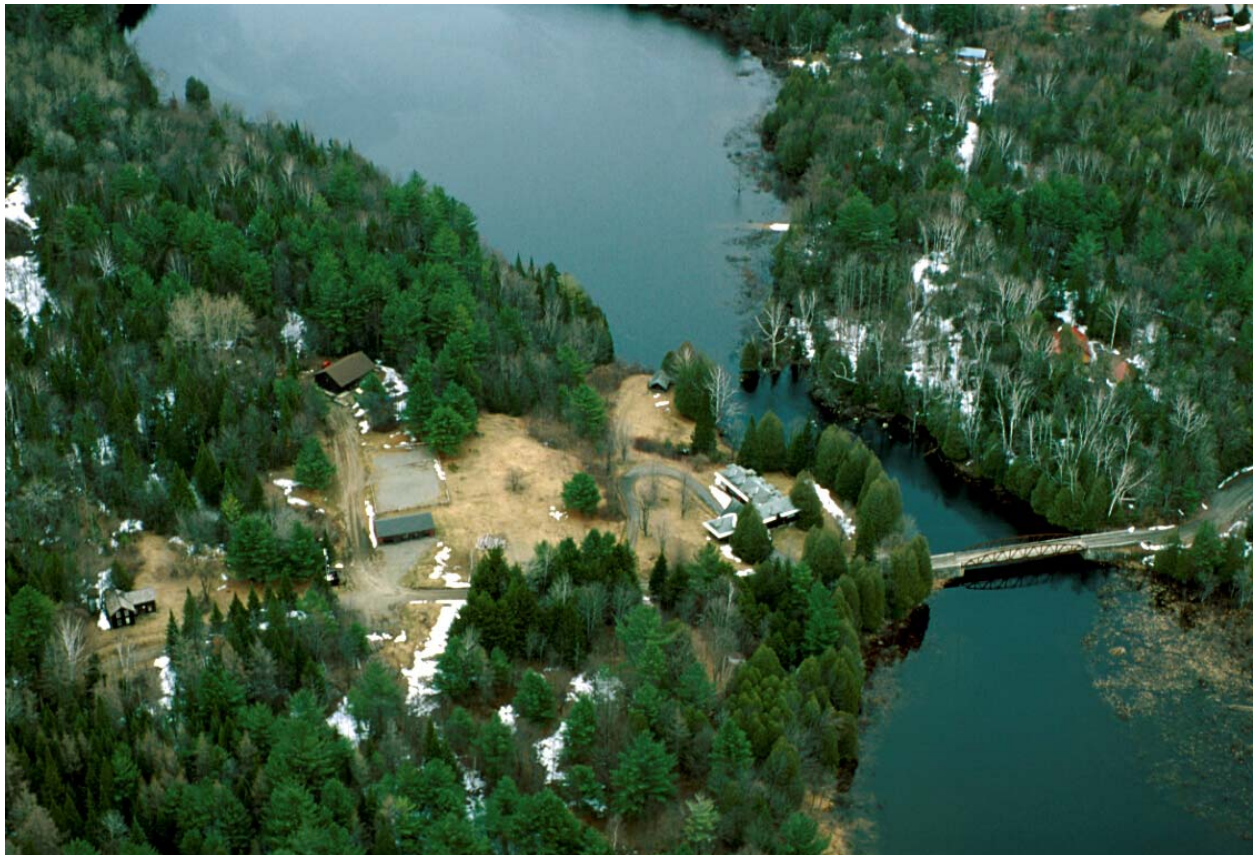
Gate Lodge Complex (2000)

The original Gate Lodge Complex contained the Gate Lodge, a frame carriage house/barn, a small boat house and a frame house (known as the Guide's House) which had several small out buildings. Only the Gate Lodge, boat house and Guide's House remain. A frame garage, which does not appear to be in its original location, is also present on the site. The garage is constructed of materials and is of a style consistent with other Camp Santanoni buildings but its original location and date of construction are not known.

The Gate Lodge was stabilized in 2006-2007. This work included major repairs to the foundation, replacement of the roof, and repair of decorative trim, painting and staining. The exterior porch on the east end of the building has been restored to its original open state.

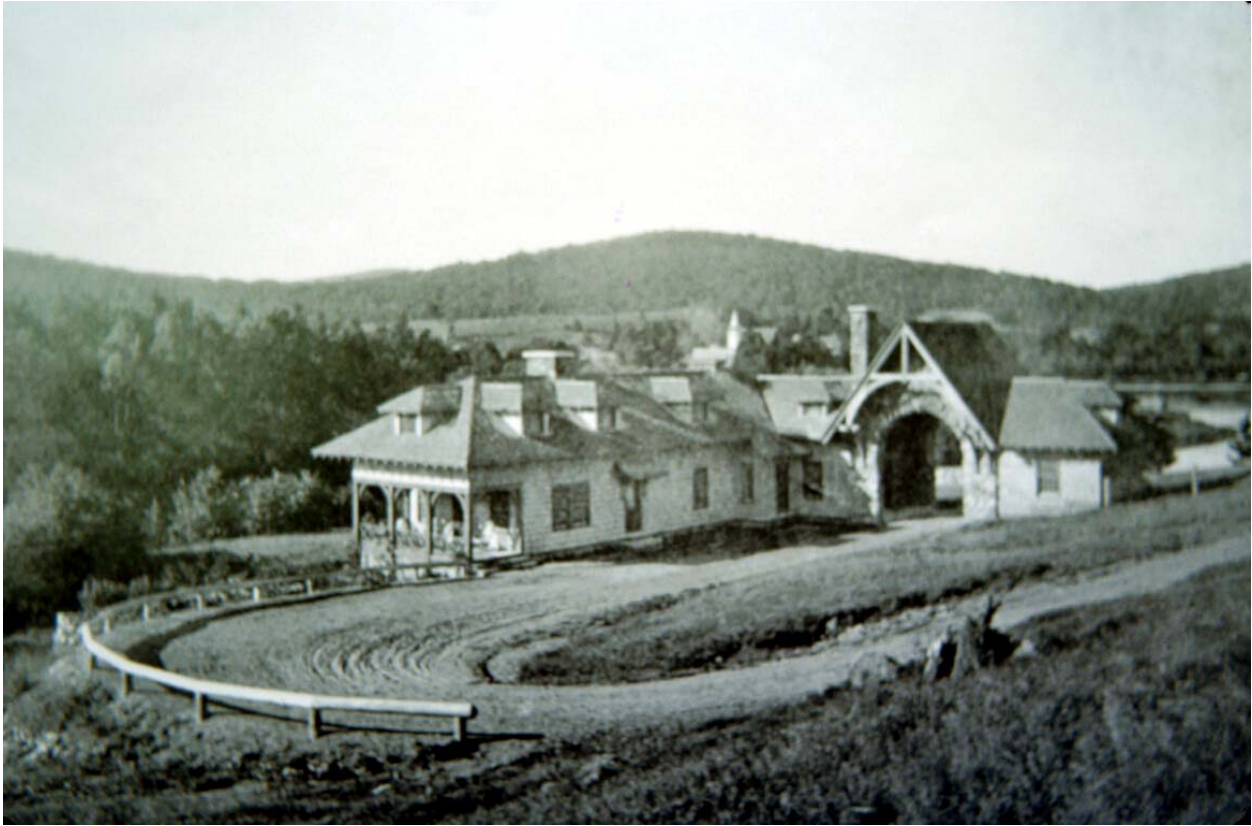
Gate Lodge (1905)

The Gate Lodge is the dominant surviving feature of this complex. It is an L-shaped (approximately 80 ft. x 77 ft.; 2,575 sq. ft.), gable roofed, one-and-one-half-story, field stone and shingle structure with massive stone and wood archway designed by Delano and Aldrich. Entry doors are present on all but the south side of the building. The first floor of this structure contains a foyer, kitchen, utility room, dining room and a living room as well as two lavatories and a porch aligned along a hall along the north wall of the building. A first floor storage room is located on the north side of the arch. The second floor contains six small bedrooms and a full bath aligned along a hall under the north eave. Several dormered windows are present along this hallway. The structure has a full basement with several internal partitions as well as a small crawlspace above the second floor. The original entry road was conveyed under the stone arch by stone walls, now breached, which extended to the entry bridge over Fishing Brook.

The Gate Lodge was modified around 1977-1979, when the structure was used to house members of the Youth Conservation Corps. The two first floor lavatories appear to have been added at this time, the kitchen and second floor bath modernized and showers were added in the basement. The buildings utilities consisting of electricity, water and septic were also upgraded. The roof was also replaced during this period. The structure is considered to be in good condition.

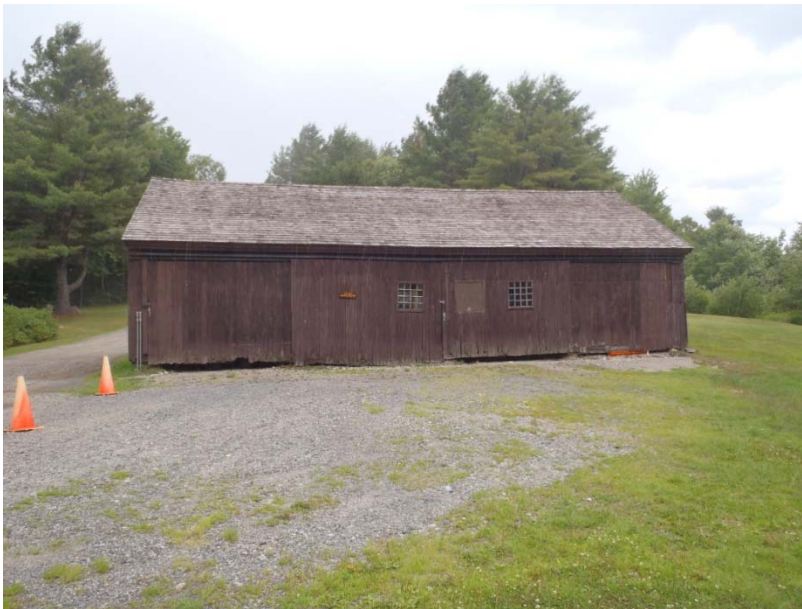
Garage (Construction date and original location unknown)

This building consists of a rectangular (24' x 47'), single-story, pole barn type, gable roofed building with vertical wood siding. This building does not appear to be in its original location, and it is unknown when it was relocated. Its fenestration suggests original construction as part of the complex. The structure is in poor condition.

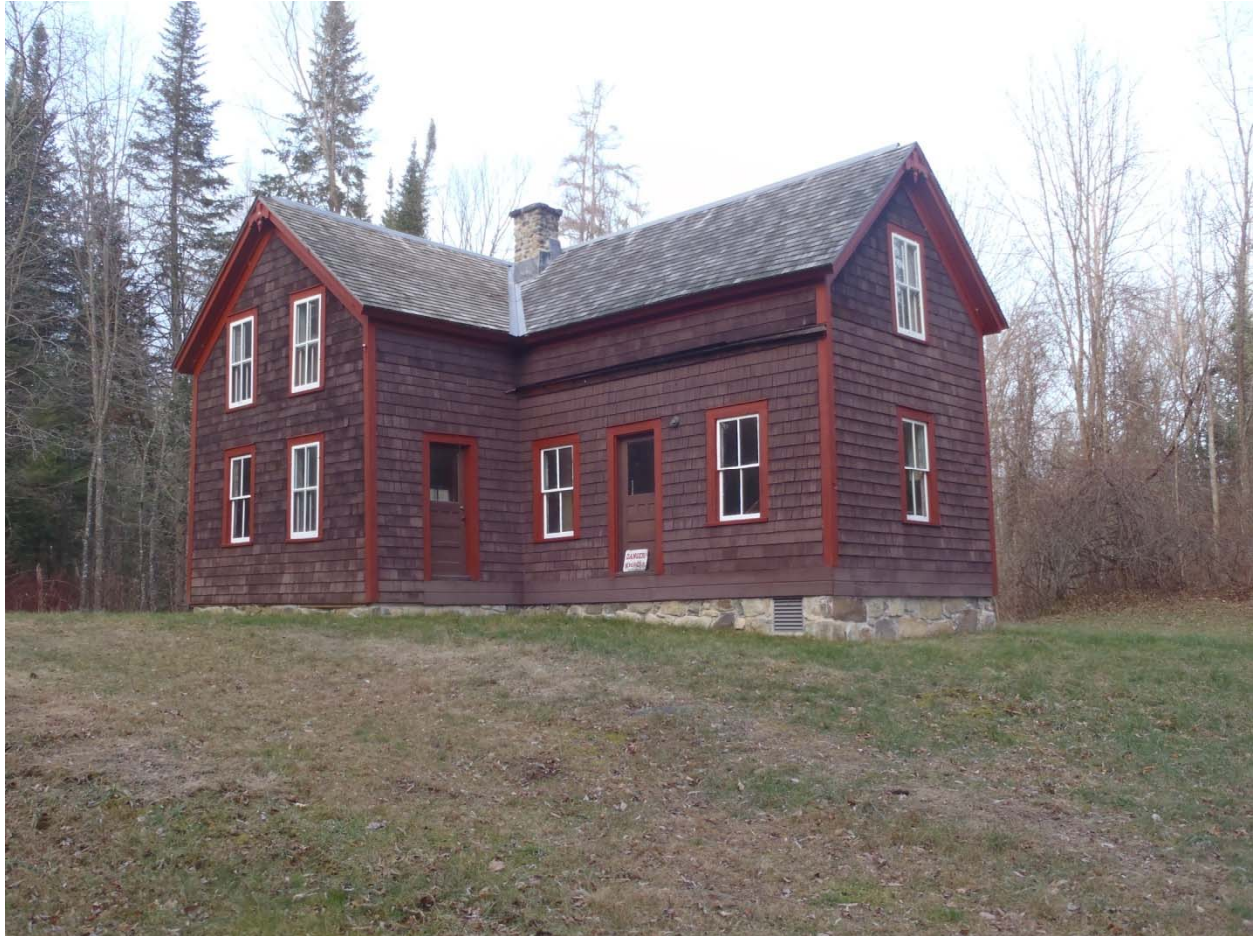
Guides House (West Cottage) (2012)

This is an L-shaped (36' x 43'), two story, wood framed, gable roofed residential structure with shingle siding. Gothic features in the exterior detailing suggest a late 19th century construction date. The structure is in good condition. Also associated with the Guide's House are the ruins of a privy, a small chicken coop and a shed of unknown function. The Guides House was stabilized in 2006 and 2007. This work included foundation, siding and other building envelope repairs, including a new roof, staining and painting.

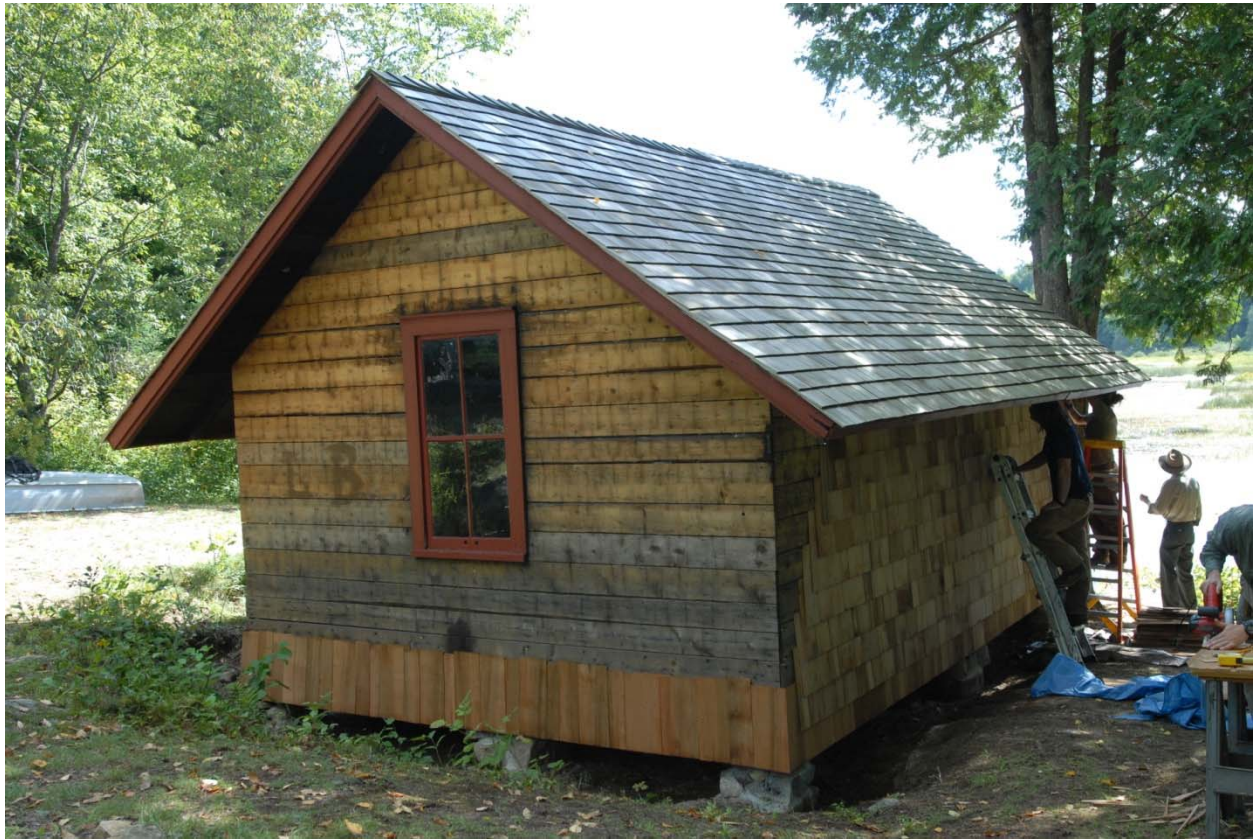
Lake Harris Boat House under restoration (2012)

This is a small storage building on the shore of Lake Harris. It is a single story rectangular (13' x 20') gable roofed, wood framed structure with shingle siding. During the term of the 2000 Camp Santanoni UMP this building was stabilized; footers were rebuilt, siding was repaired and the roof was replaced and the building was re-sided. This structure is in excellent condition.

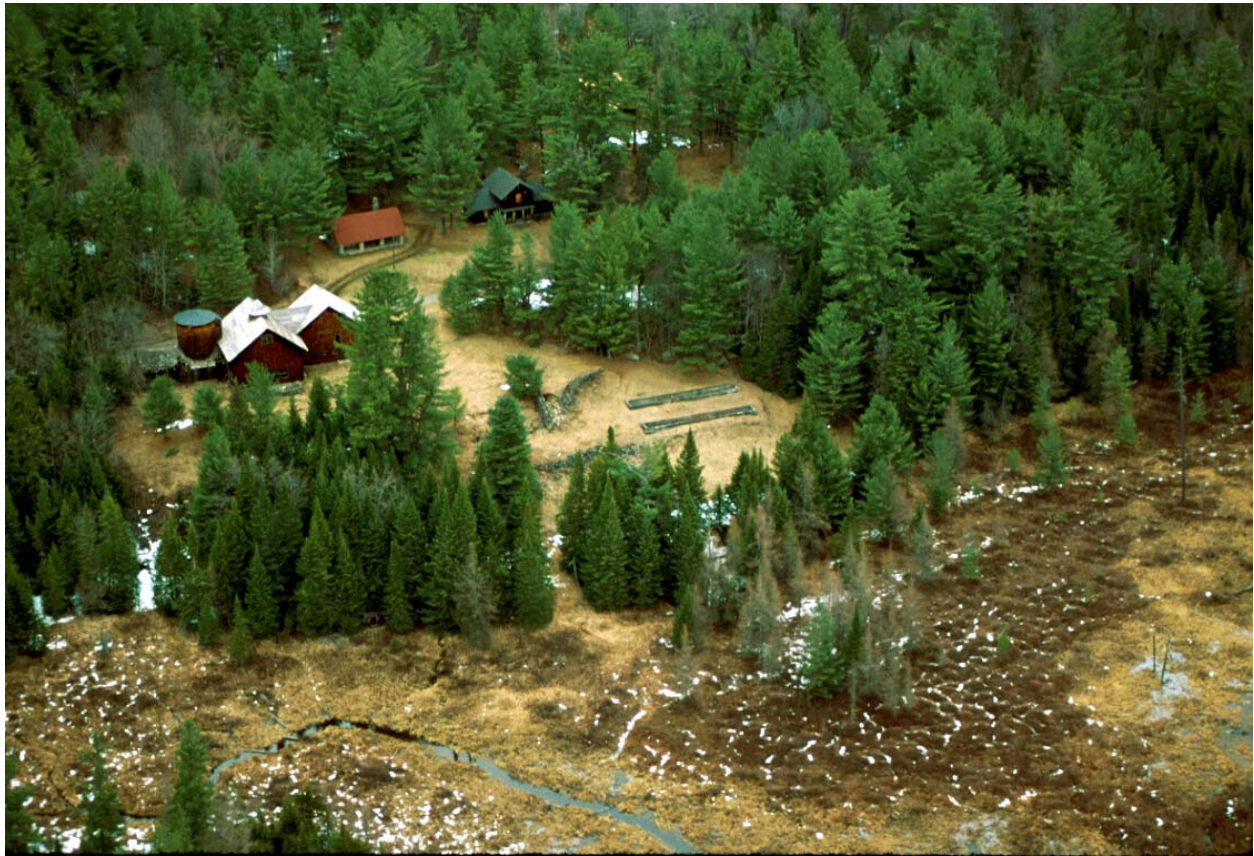
The Camp Santanoni Farm consists of five standing structures and the ruins and archaeological remains of other buildings and agricultural structures located along the Newcomb Lake Road approximately one mile north of the Gate House Complex. Begun in 1895 and expanded several times through 1920, the farm supplied vegetables, meat and dairy products to the Pruyn family, farm workers and guests both at Camp Santanoni and at the Pruyn home in Albany. At its largest extent, the farm comprised over 200 acres of cleared land in pasture, garden and orchard areas. The farm remained in active use until 1931. Approximately 25 buildings were originally present on the farm complex. In addition to the structures and ruins, remnant landscape features such as fence lines and walls are evident along both sides of the Newcomb Lake Road. The locations of garden areas, sections of pasture north of the farm and around

Farm Complex (2000)

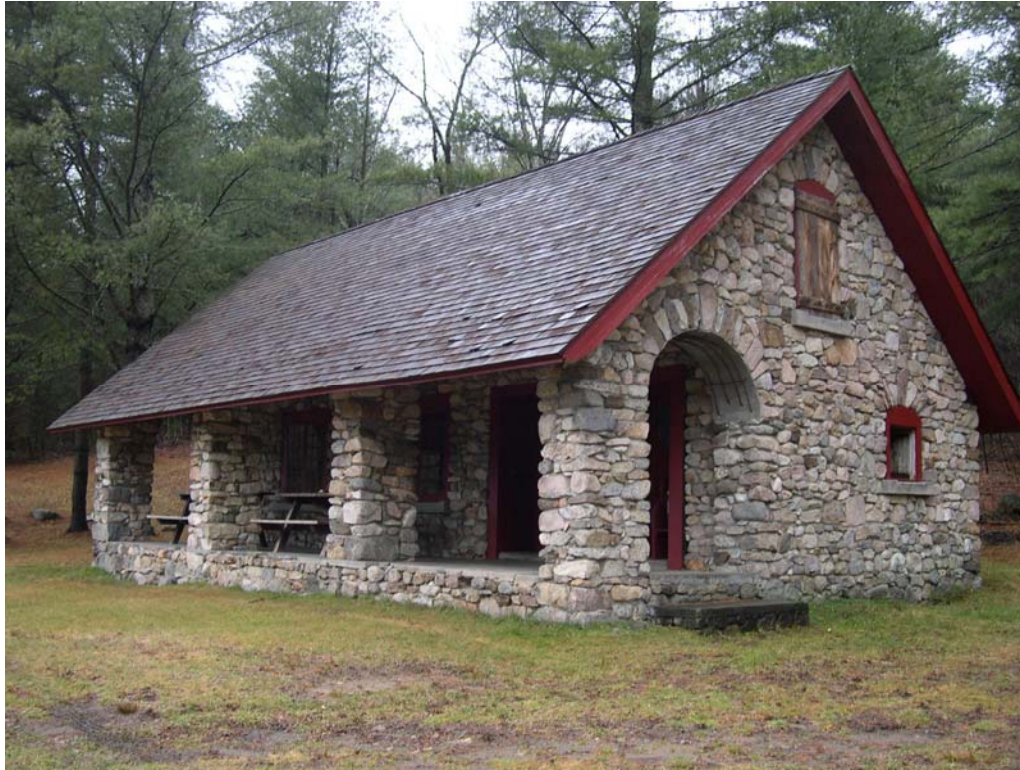
Creamery (2013)

This structure is a single story fieldstone building constructed on a concrete pad. It contains three rooms: a boiler room, wash room and milk processing room. The building has an integral porch along its south face. A cream separator, boiler and other hardware remain intact within the building. During the term of the 2000 UMP, the Creamery received a new roof, repointing and window repairs. This structure is in excellent condition.

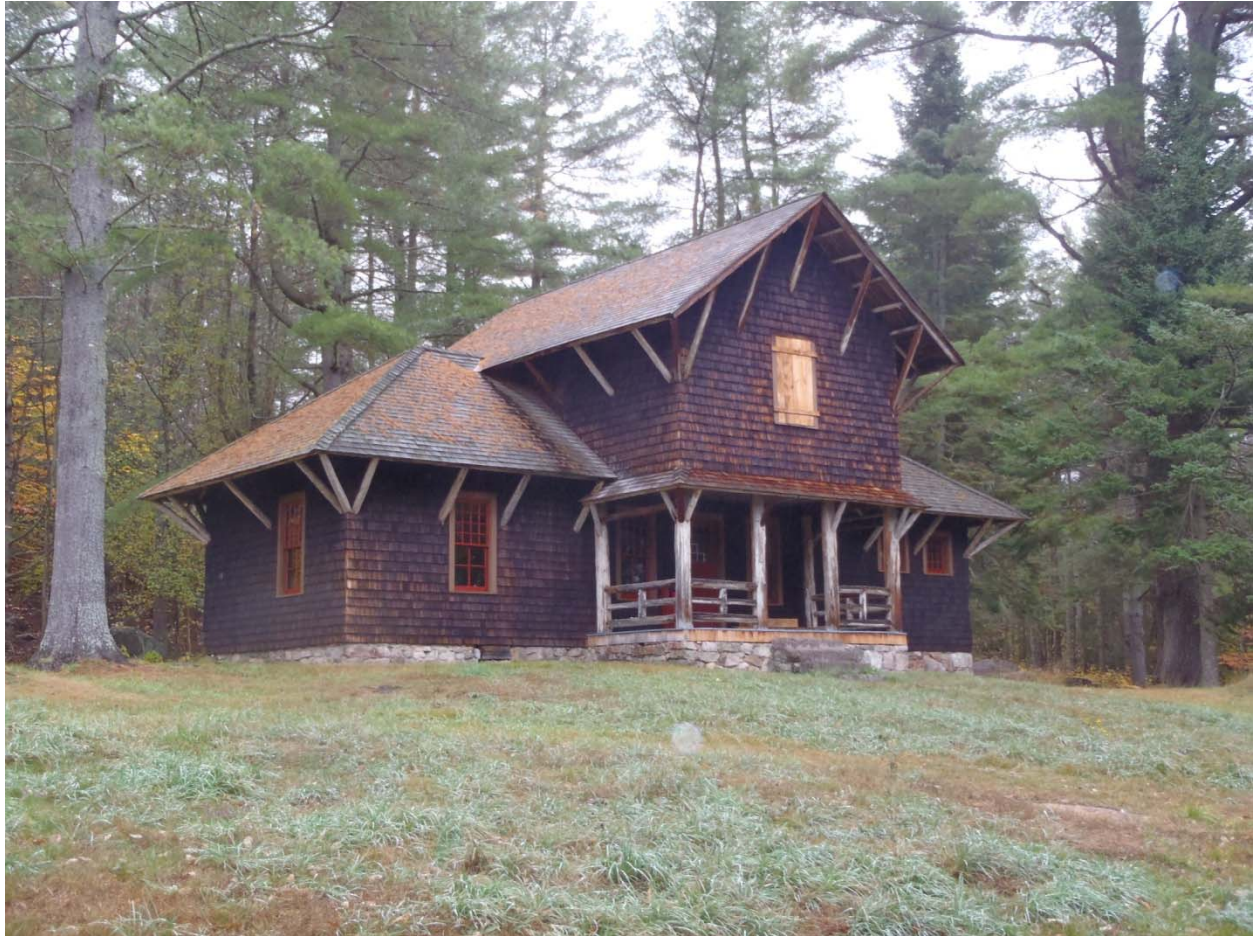
Gardener's (Petoff's) Cottage (2012)

This is a one-and-one-half-story, wood framed, gable roofed, shingled structure with recessed entry porch. Rustic features characteristic of Camp Santanoni residential buildings are present, including peeled log porch framing and under eave braces. The structure appears to have been constructed as part of the expansion and redesign of the farm complex undertaken by Edward Burnett. It was expanded at least once in its history. The cottage contains a parlor, kitchen, laundry room, pantry, three bedrooms, a bath and an attached wood shed. The exterior of the structure retains its original design and finishes. The interior of the structure was modernized, probably during the Melvin period, although original woodwork and moldings remain. Structurally, the building is in good condition.

The Environmental Protection Fund grant received in 1996 provide for the maintenance of the Gardener's Cottage which is a highly significant component of the Farm Complex. Work completed includes stabilization and restoration of the missing and damaged, structural members and exterior walls, interior floors and walls of the building, replacement and repairs of missing or broken windows, and making the building weather-tight. This work has been completed.

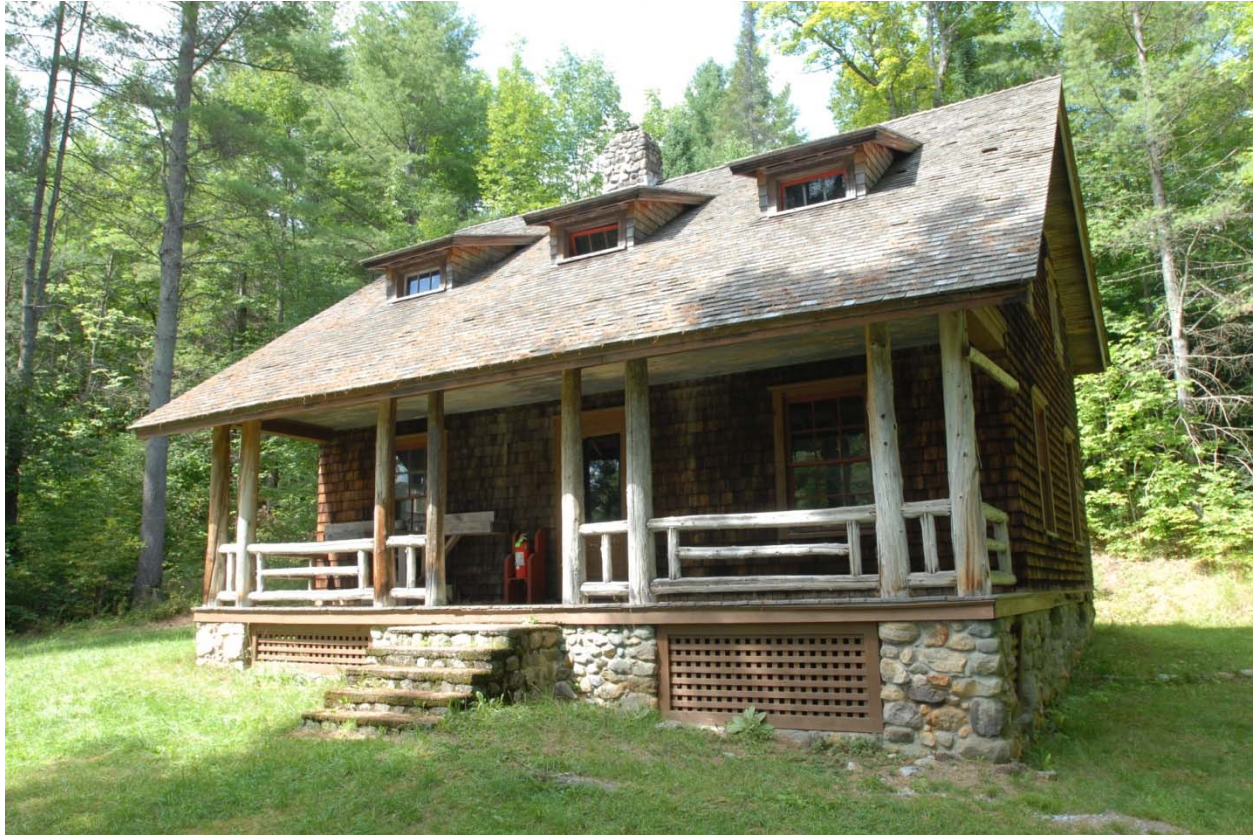
Herdsman's (Ross') Cottage (2012)

This is a one-and-one-half-story, wood framed, gable roofed, shingled structure with recessed entry porch and cobblestone chimney. This structure appears to predate the Pruyn occupation of the property and may represent the residence of a mid-nineteenth century farmstead believed to have existed on the property by ca 1850. The Herdsman's cottage also exhibits rustic features such as peeled log porch frame and under eave braces. The building appears to have been remodeled several times during the Pruyn occupation with stylistic details comporting with newer buildings added to the farm complex. The exterior of the structure retains its original design and finishes. This cottage contains a parlor, dining room, kitchen, serving pantry, a bedroom and an attached wood shed on the first floor. The second floor contains a full bath and four bedrooms. The interior of the structure was modernized, probably during the Melvin period.

The Environmental Protection Fund grant received in 1996 provide for the maintenance of the Herdsman's Cottage which was in poor condition but is a highly significant component of the Farm Complex. Work completed includes stabilization and restoration of the missing and damaged, structural members and exterior walls, interior floors and walls of the building, replacement and repairs of missing or broken windows, and making the building weather-tight. This work has been completed.

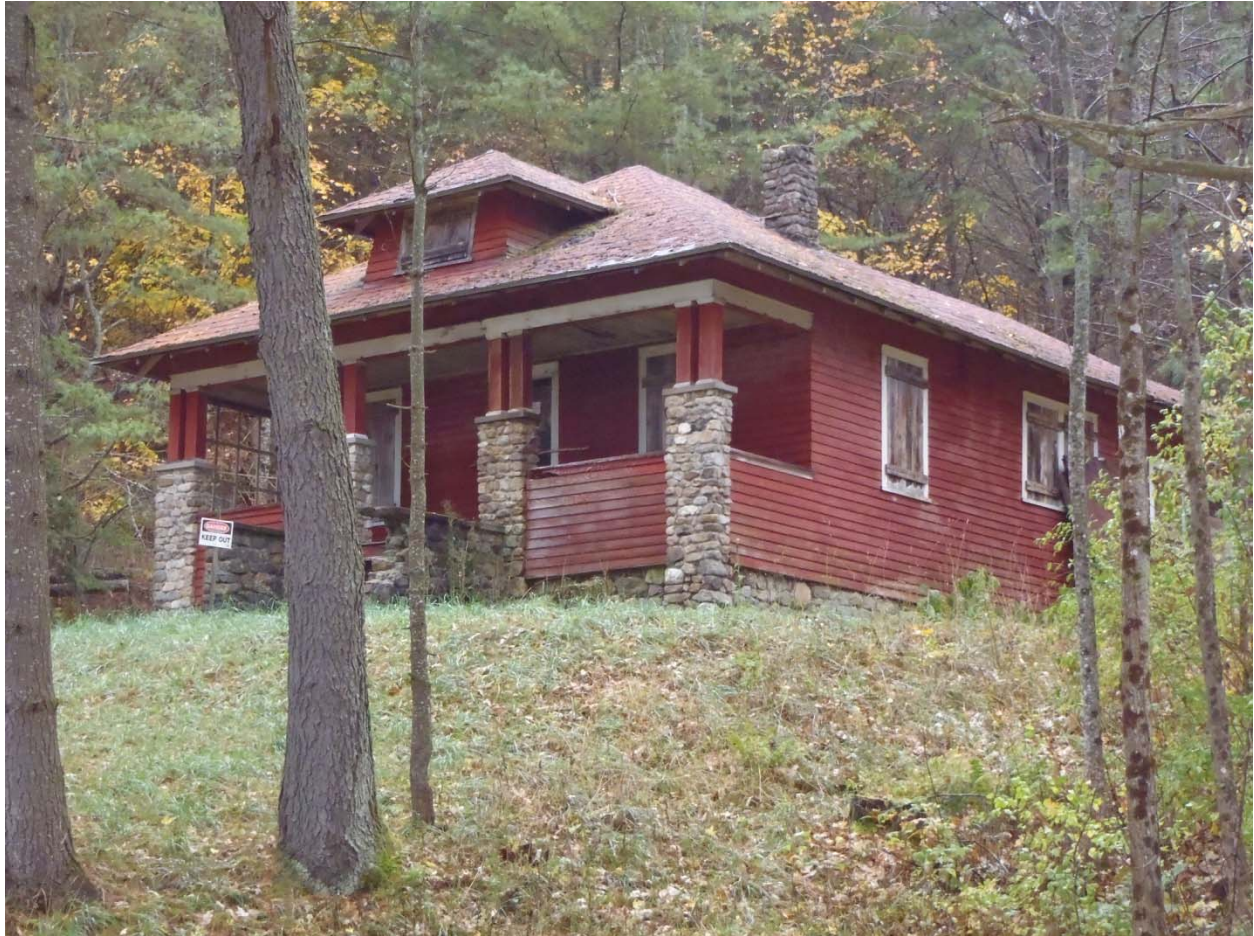
Caretaker's or New Farm Manager's (Tummins's) Cottage (2012)

Also known as the Farm Manager's Cottage, this is one-and-one-half-story, wood framed, hip-roofed bungalow style, clapboard sided structure with recessed entry porch. The building is distinctive compared to other buildings on the property, having as its core a Harris catalog house. The structure was occupied by employees of the Pruyn's and the Melvin's from 1919 through 1974. The building retains its original exterior features and trim, but the interior has been modernized. Structurally the building is in very poor condition. A project was undertaken in 2013 to replace the roof and stabilize this structure and remains under way.

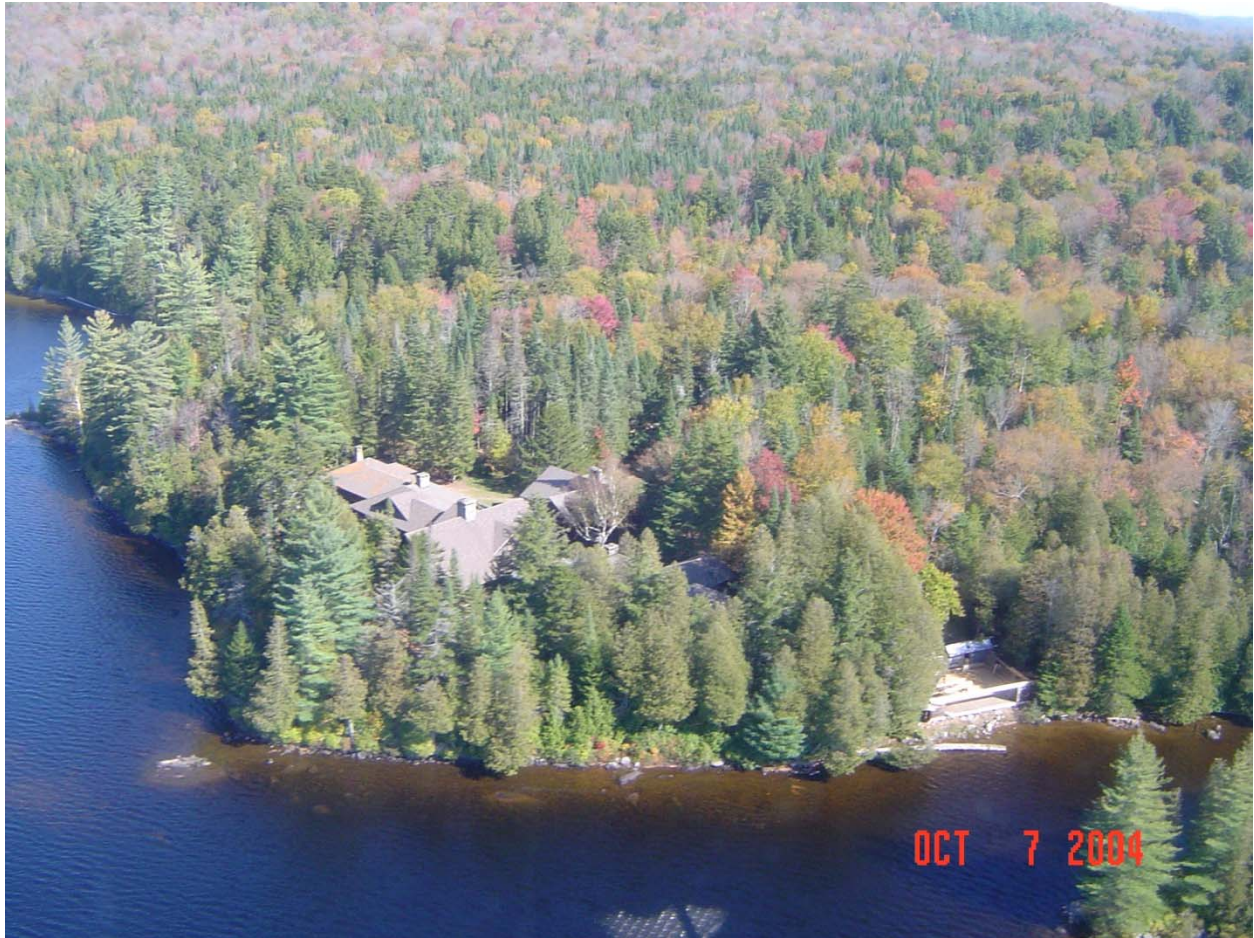
Main Lodge (2004)

The lodge is composed of five log pavilions under an immense roof with wide overhangs and hip-roofed projections including a gable roofed porte-cochere. It has been characterized as a log villa. The center pavilion consists of a great one-and-one-half-story living hall with massive stone fireplace. It is flanked on opposite (east & west) sides by four sleeping cabins/cottages. The structure covers an area of 15,000 square feet. During the term of the original UMP repairs were made to structural components of the porches and much of the decking was replaced.

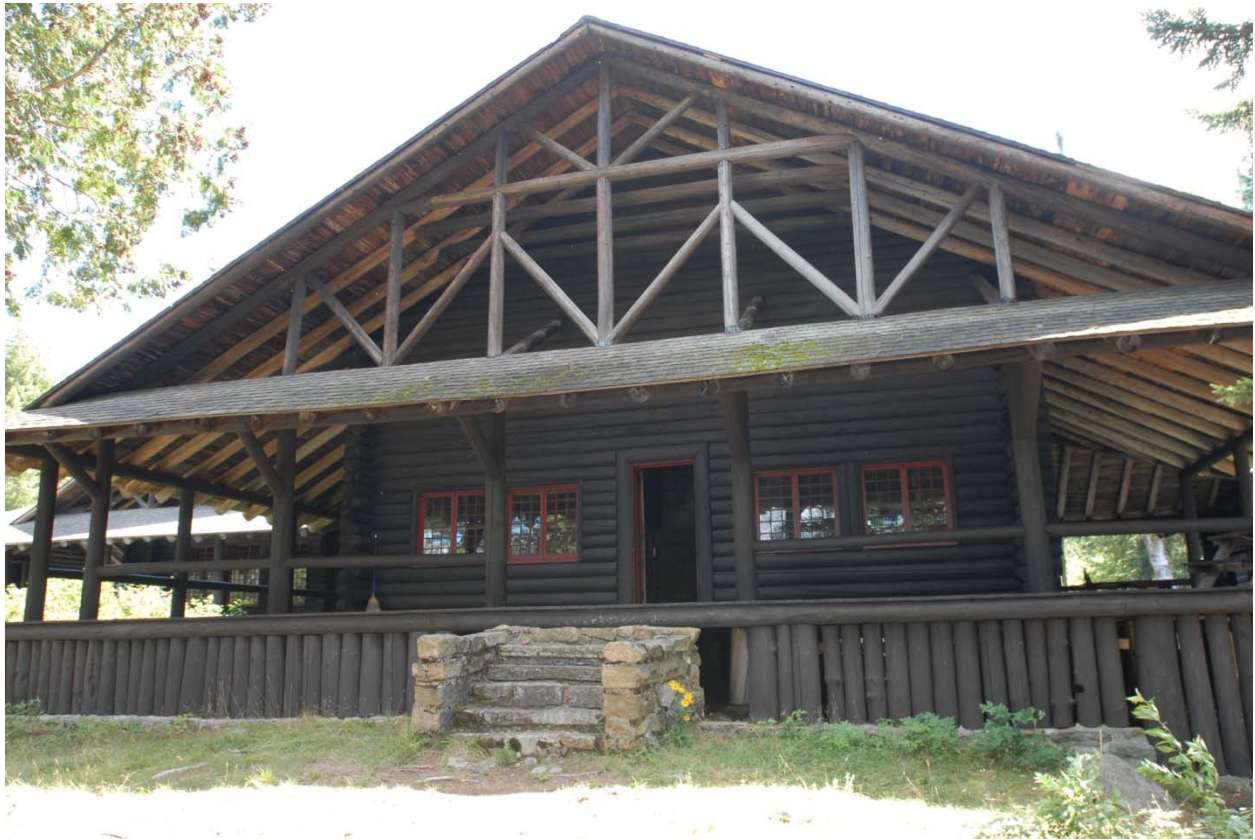
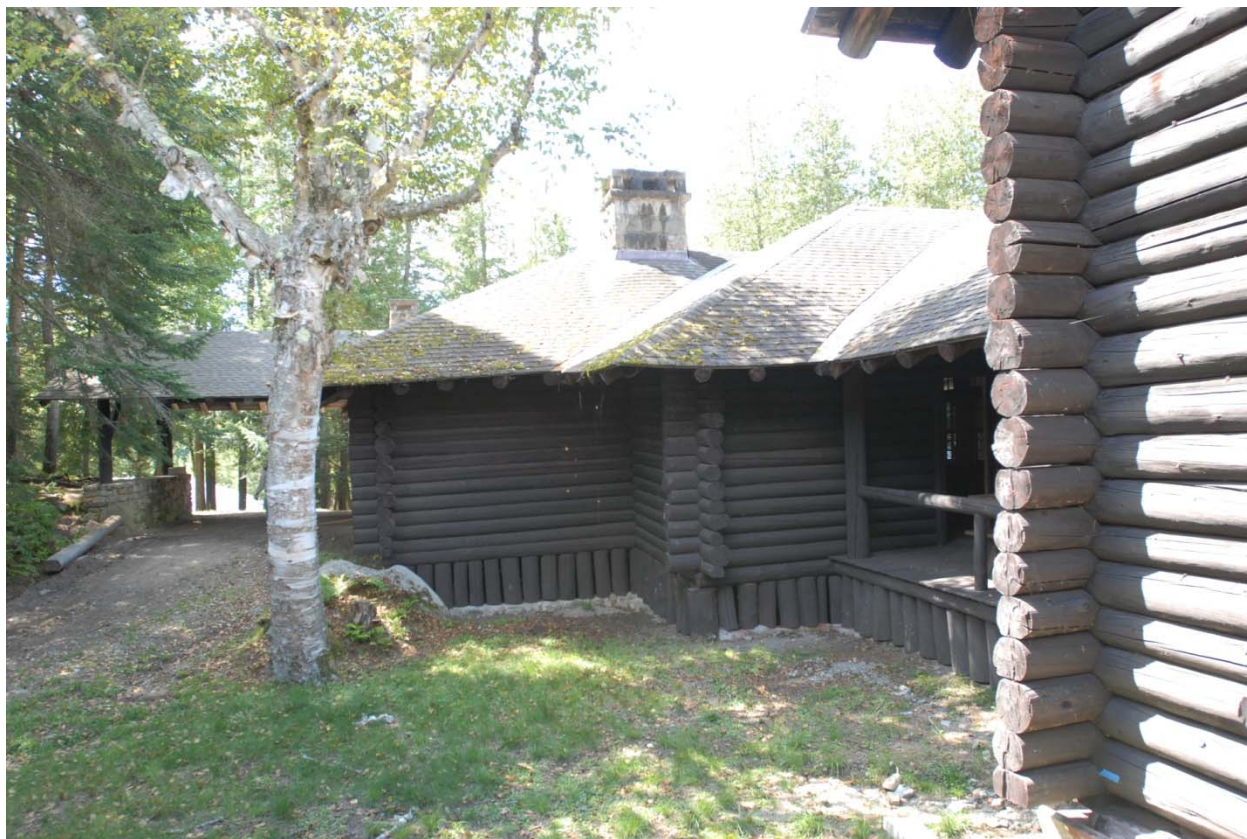
Main Lodge (2012)

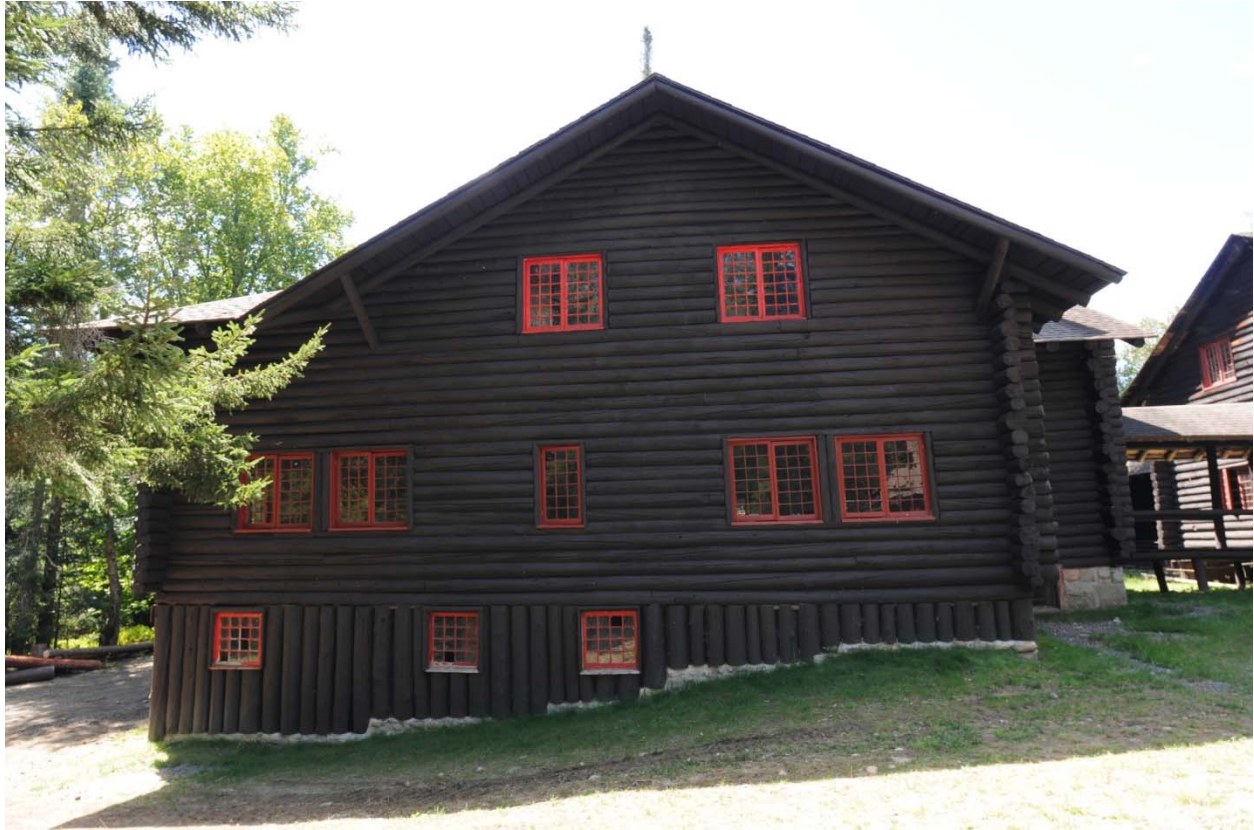
Main Lodge Kitchen Wing (2012)

This is a detached, three story log structure (50' x 50') on log piers connected to the main lodge via a covered walkway. It includes a massive ashlar stone chimney and built-in ice chests on a recessed porch. The Kitchen Wing has been stabilized and has had its foundation reinforced. Significant work remains in stabilizing and repairing interior components.

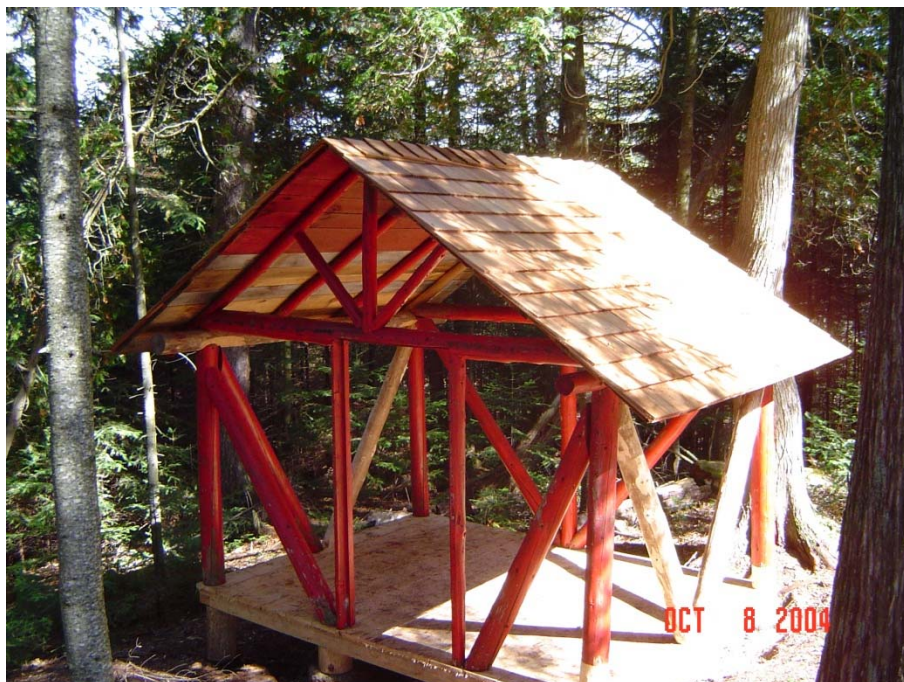
Gazebo (2004)

This is a small (7' x 10'), log braced and log supported single-story screened pavilion. This structure has been stabilized and re-roofed.

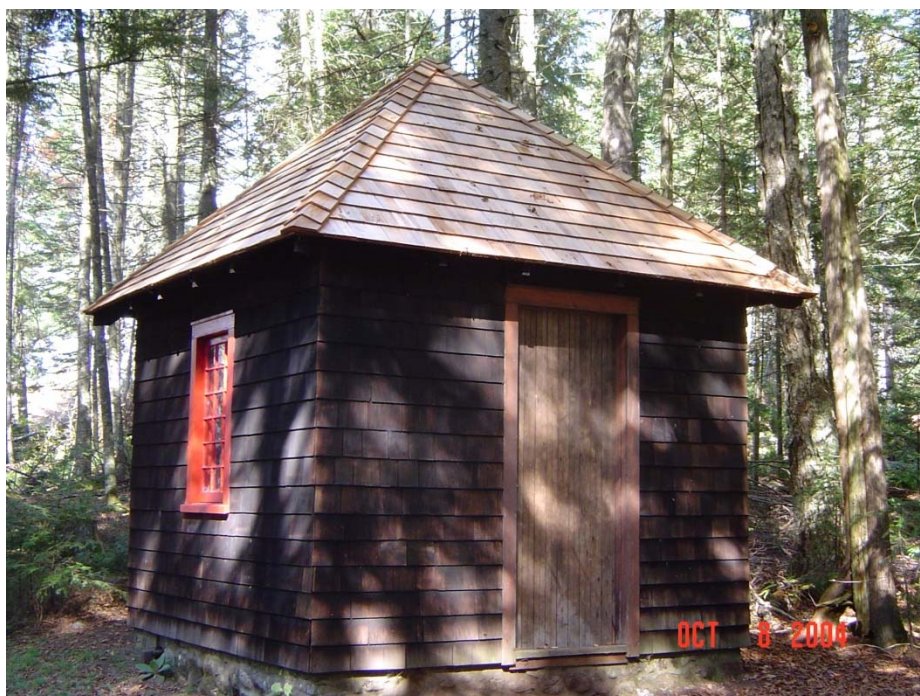
Power House (2004)

This is a very small, square (8' x 6'), single-story, shingled, wood framed building. The generator in the power house operated an “on demand” electrical system which was wired to the Main Lodge. This building has been stabilized with a new roof and window restoration.

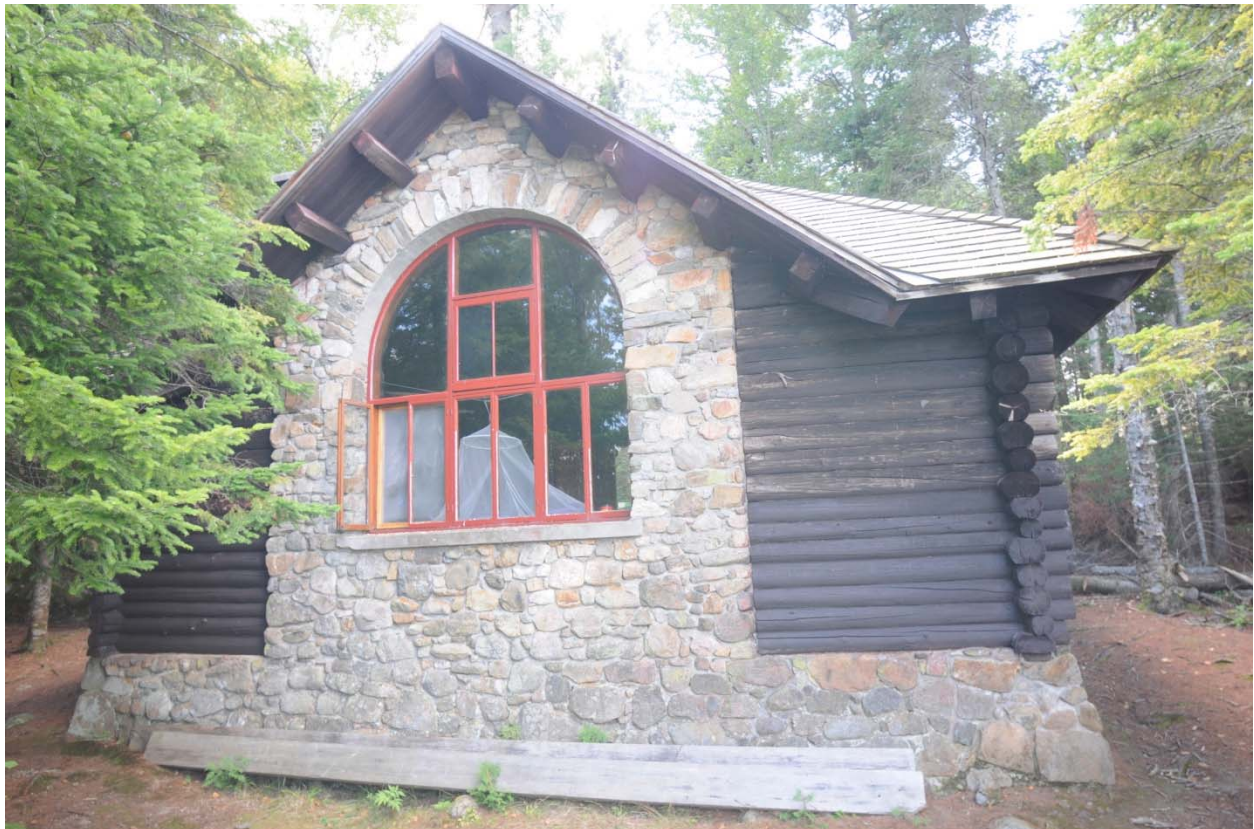
Artist's Studio (2012)

This is a small, single-story, rectangular (19' x 28') log structure with a hipped roof. Sited along the shoreline of Newcomb Lake, it features a stone-arched lakeside window as well as a stone chimney and fireplace.

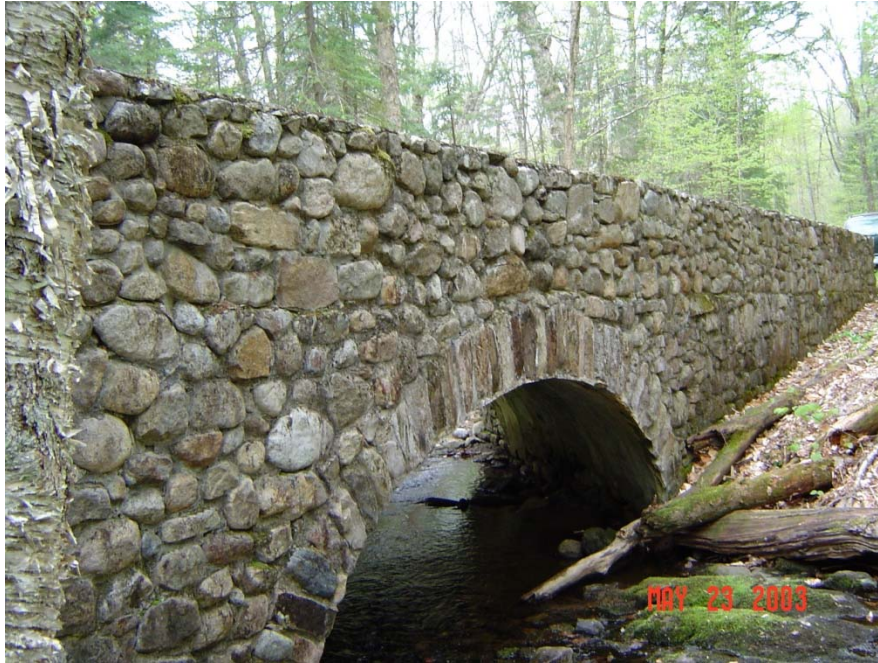
Outer Twin (2003)

This is similar in size and condition to middle culvert, although spandrel walls have not been displaced as severely. This structure was rebuilt in 2013-2014.
