Limekiln Lake Public Campground

Unit Management Plan

Proposed Final

**LIMEKILN LAKE PUBLIC CAMPGROUND
SITE SPECIFIC - VOLUME II
PROPOSED FINAL UNIT MANAGEMENT PLAN**

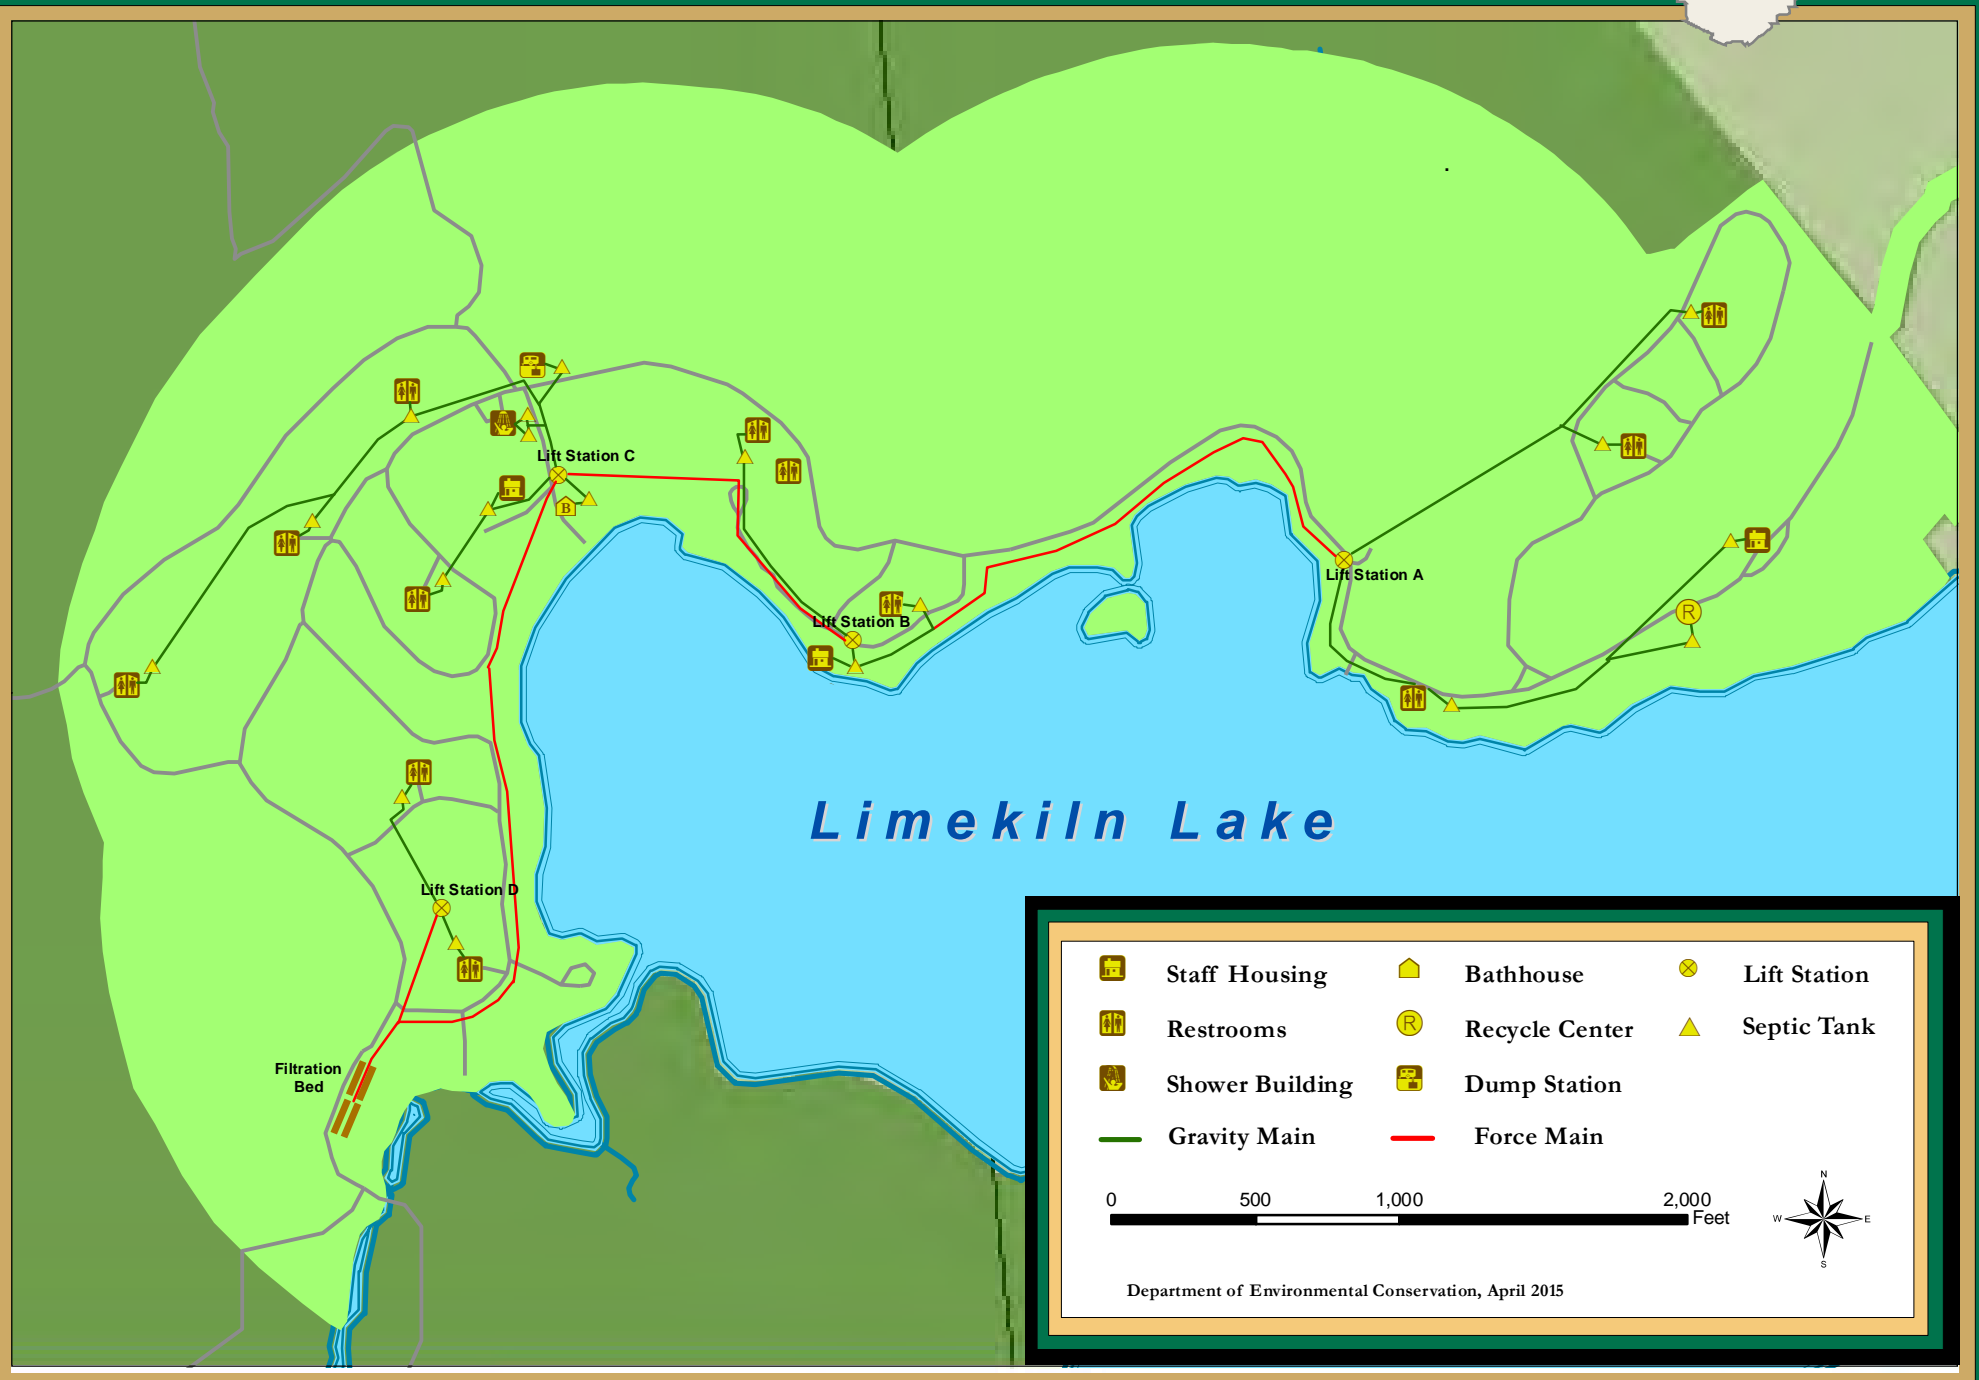
Exhibit # 7 - Electric Facilities Map

The main campground has overhead primary electrical distribution and overhead secondary distribution. National Grid provides electricity to the campground's primary service. The DEC owns and maintains all utility lines on the campground. Average annual electric consumption is 36,500 kWh at a cost of \$4,550. (See Exhibit #7)

Limekiln Lake is a large campground with over 9,000' of primary overhead and 8,400' of secondary overhead power lines running through a facility that is heavily wooded in many locations. There is currently about 2,000' of buried electrical service. Like all campgrounds in the area, it is subject to heavy storms with strong winds and lightning strikes. The overhead lines are in constant need of maintenance and have required emergency repairs several times resulting in the power being off in the facility for extended periods. Over time the lines have had many splice repairs that further weaken the durability of the lines. This management action proposes to have the overhead power lines buried and the 6 pole transformers moved to a ground pad location.

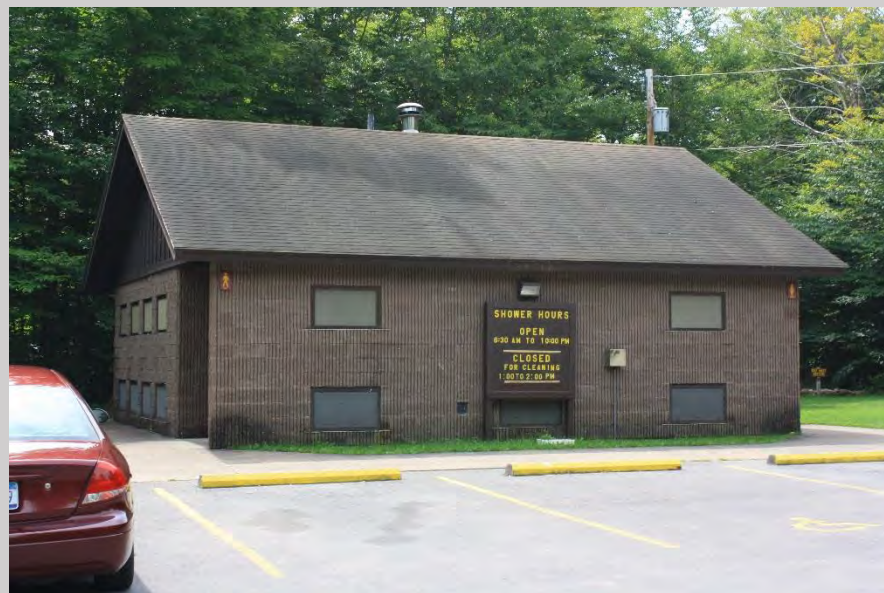
Shower Building

2. Comment received about the condition of the existing shower building (missing tiles, lack of drain covers) and no plan to make repairs.

Response – The lack of an action in this plan to make repairs to this building were based on the most current building condition report. Your comment will be forwarded to the regional office for action.

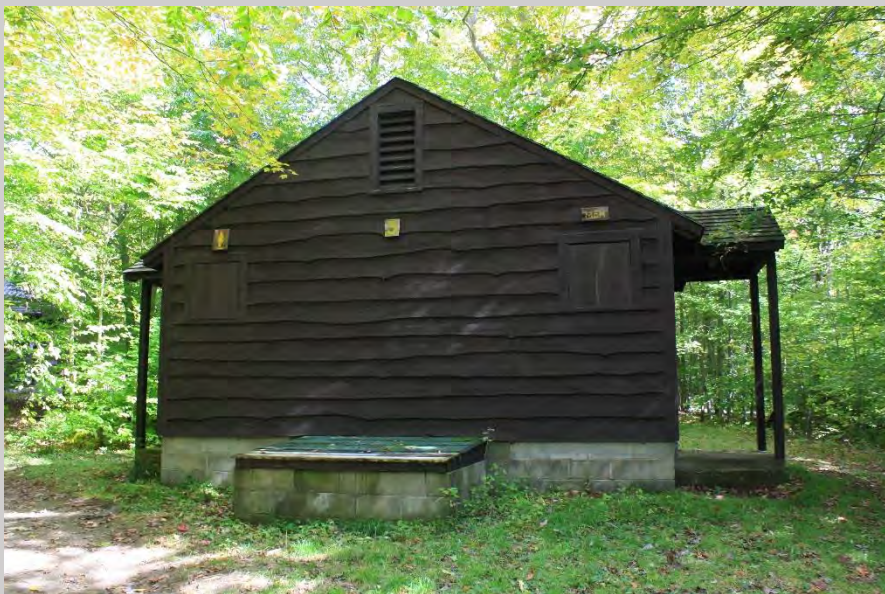
Comfort Station # 3 (Vault)

Comfort stations 1, 2, 4-12 have 8 flush toilets (4 per sex) 2 lavatories (1 per sex). Comfort station 3 is a vault toilet with 6 toilets (3 per sex) and 2 lavatories (1 per sex). Bathhouses have 4 flush toilets (2 per sex) and 2 lavatories (1 per sex). The shower building has 8 showers (4 per sex) The men's shower has 1 toilet, 1 urinal and 4 sinks; the women's shower has 2 toilets and 4 sinks. Total for campground 102 toilets, 34 lavatories and 8 shower units.

There are currently eight showers available to campers which is 14 showers deficient of meeting DEC design standards. In addition, in 2014 the existing shower building was noted to lack required accessibility design standards. Comfort Station #3 is currently a vault style toilet building and not in use. It is located to the east of the existing shower building. Comfort station # 8 is located in an area south of the existing shower building. Replacement of both of these buildings will remedy deficiencies noted above. The new buildings will be adjacent to universal campsites proposed in management action D.
