# Lower Chateaugay Lake Survey Site Numbers

# Chateaugay Lake Aquatic Plant Survey Report

Prepared for: Chateaugay Lake  
Foundation

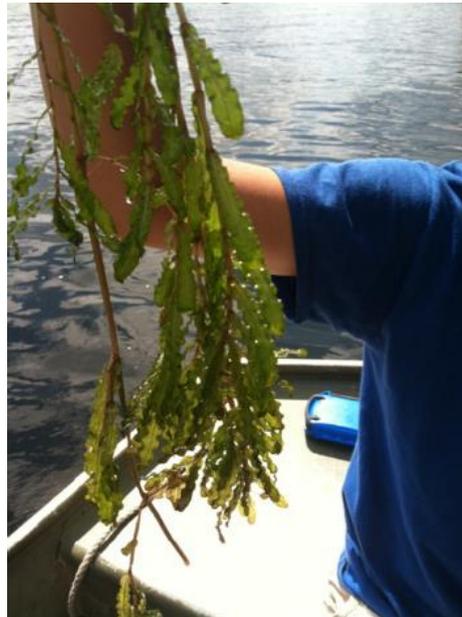
*Figure 25. Curly-leaf pondweed found in Upper Chateaugay Lake in 2014.*

Though the invasive species Curly-leaf pondweed was not found in Chateaugay Lake during the 2021 plant survey, it was found in Upper Chateaugay Lake in 2014 (**Figure 25**). The lake should be closely monitored for the recurrence of this species. Curly-leaf pondweed produces turions (winter buds) that fall to the sediment at the lake bottom and can remain dormant for several years before sprouting. If any turions remain at the bottom of Chateaugay Lake, there is the potential for recurrence. Curly-leaf pondweed is easily identifiable by its ‘lasagna-shaped’ leaves. This species grows early in the season and dies off by mid- to late-summer.

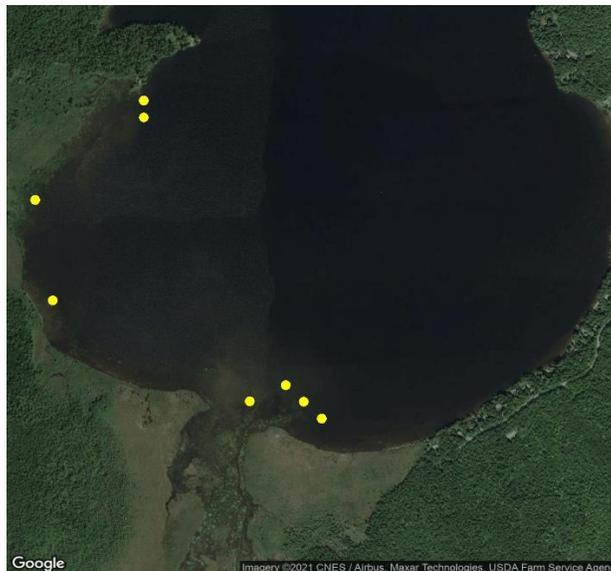
**Figure 28.** Locations of Farwell's milfoil (yellow dots) in the southern portion of Upper Chateaugay Lake.

Farwell's milfoil was found at eight locations in the southern section of Upper Chateaugay (**Figure 27**). Occurrences were fairly spread out, with some of the plants being found directly outside of the South Inlet and with some being found on the western side. Farwell's milfoil can be identified by the alternate and whorled nature of its leaves (distinguishes it from *M. alterniflorum* and *M. humile*). The presence of fruits on the submersed stems distinguished it from *M. pinnatum* (**Figure 28**).

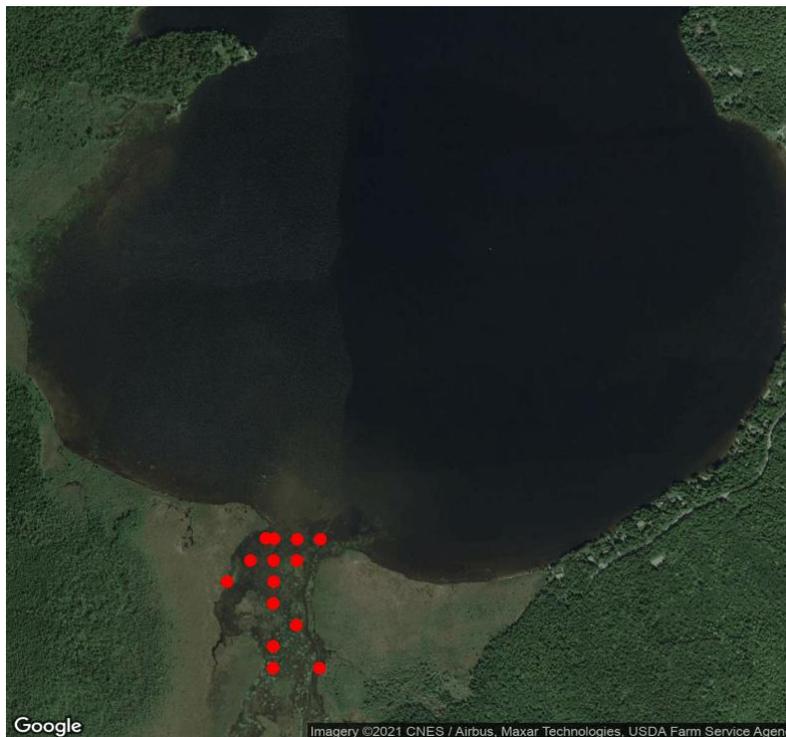
**Figure 30.** Locations of Mare's tail (red dots) in the southern portion of Upper Chateaugay.

Mare's-tail, the only protected plant species with endangered status in the Chateaugay Lakes System was found abundantly throughout large portions of the South Inlet Area (**Figure 29**). Mare's Tail was found in 13 locations in 2021, but this distribution is most likely an underestimate of the species' true coverage, which can be seen in **Figures 30 & 31**.

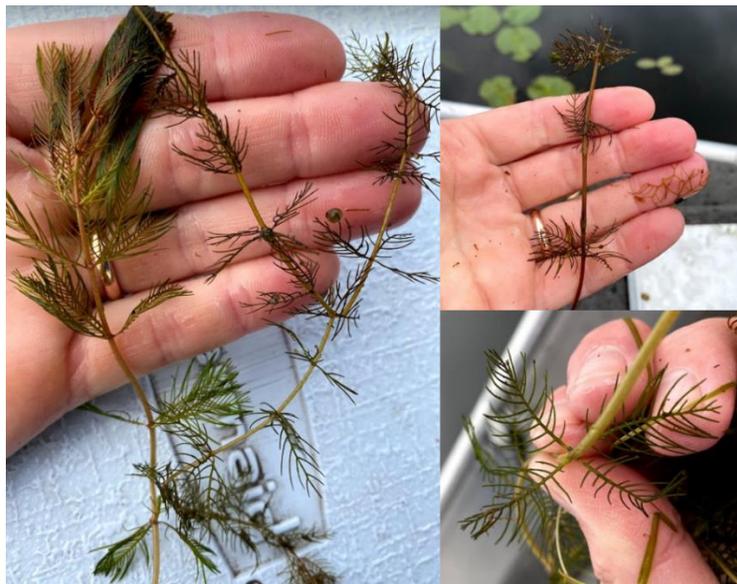
**Figure 34.** Specimens of EWM and other milfoils from Chateaugay with varying leaflet counts.

During the survey, multiple specimens of EWM were observed that had distinctly different characteristics than what is considered standard for the species (**Figure 33**). The most striking characteristic was the number of leaflets, which varied greatly between plants. Some plants had 16 leaflet pairs while others had only 6. EWM usually has over 12 pairs of leaflets on each leaf (Crow and Hellquist). The specimens also did not exhibit typical characteristics of Northern Watermilfoil (*Myriophyllum sibiricum*). It has been known for about 20 years now that EWM can hybridize with other milfoil species, such as Northern Watermilfoil (Moody and Les 2002). Morphological characteristics alone are not sufficient to identify hybrid Watermilfoils in the field. Moody and Les (2007) examined morphological data from Watermilfoil species that also had genetic analysis done to identify lineage. They found that they could easily distinguish between invasive EWM and native Northern Watermilfoil using morphology but could not identify hybrids using morphology alone.

Hybrid Watermilfoils don't just represent another aspect of lake ecology and intermixing of species, they can pose significant issues for management. Hybrid Watermilfoils have been shown to have increased growth rates, increased sexual reproduction potential and increased tolerances to some herbicides compared to non-hybrid plants (LaRue et al. 2012; Berger et al. 2017; Glisson and Larkin 2021). There is significant genetic variation even within hybrid Watermilfoils, which each have specific traits which allow them to thrive in a variety of conditions (Taylor et al. 2017). Not every hybrid milfoil will have the same tolerance to specific herbicides, meaning that identification of specific genotypes for lakes may be more important than just knowing if a hybrid is present.
