Barton Mines Geotechnical Review

**Bowman Consulting, Engineering, Land Surveying and
Landscape Architecture**

Barton Mines
North Creek, NY

August 2024

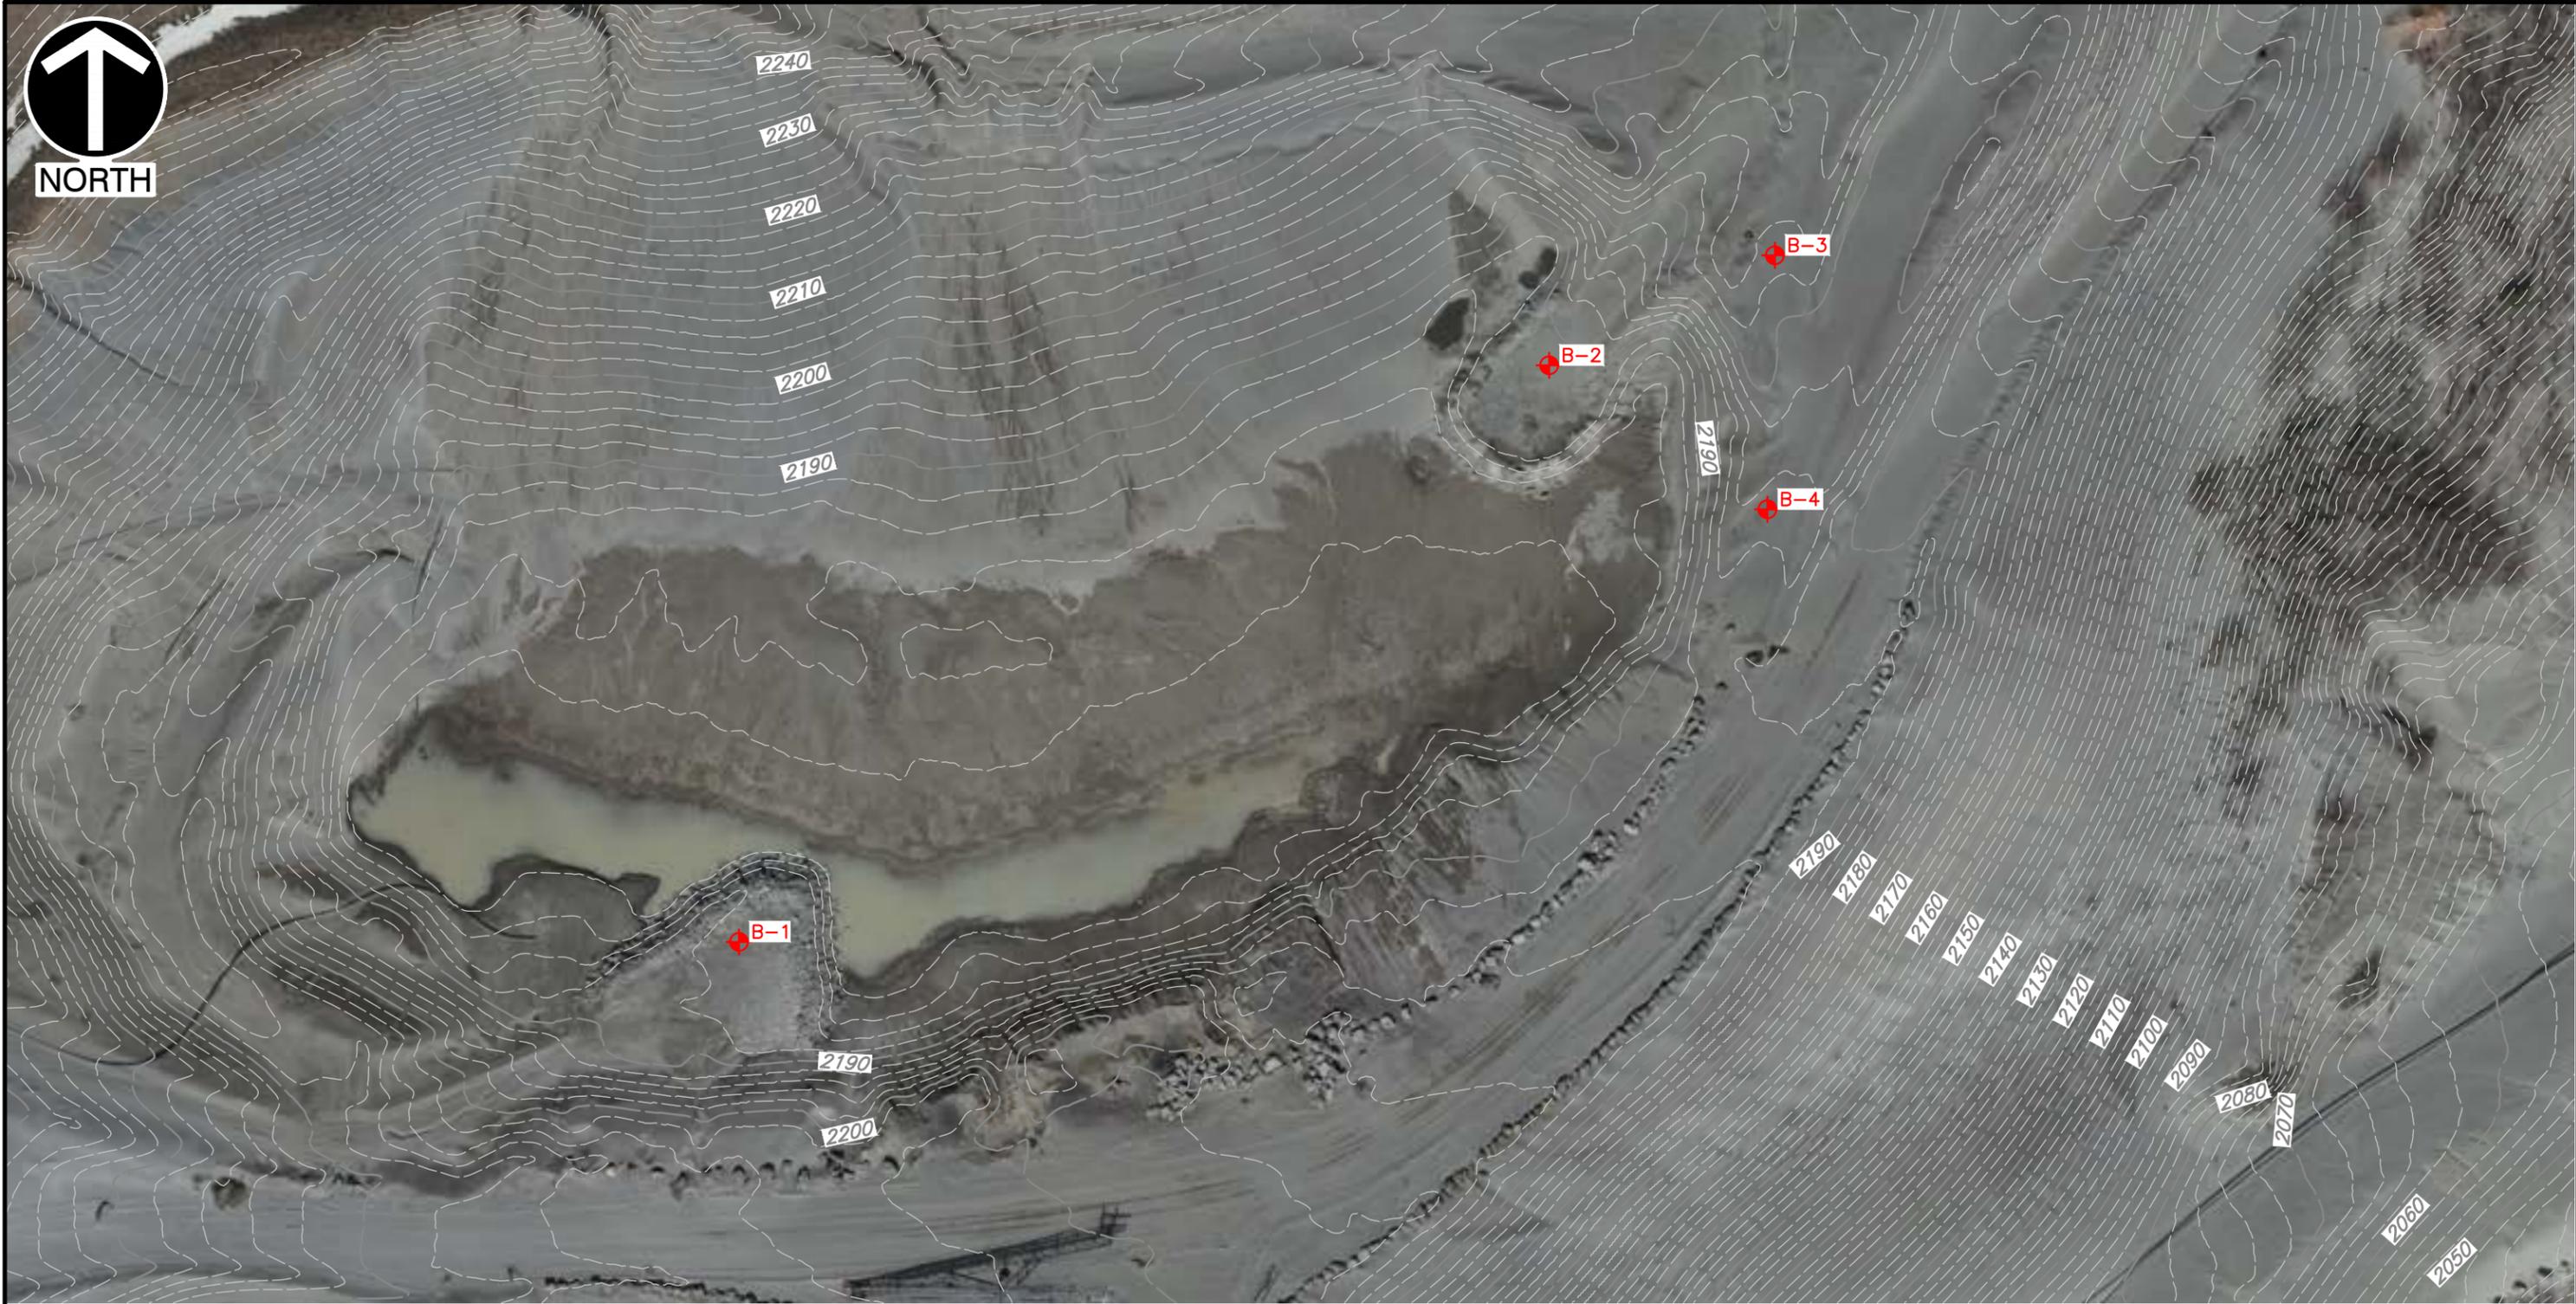
- 1250 EXISTING INDEX CONTOUR
- EXISTING INTERMEDIATE CONTOUR
- APPROXIMATE TEST BORING LOCATION

Appendix C – July 2024 Middle Pond Boring Logs and Location Map
