Sharp Bridge Public Campground

Unit Management Plan

Public Draft

SHARP BRIDGE PUBLIC CAMPGROUND SITE SPECIFIC - VOLUME II UNIT MANAGEMENT PLAN

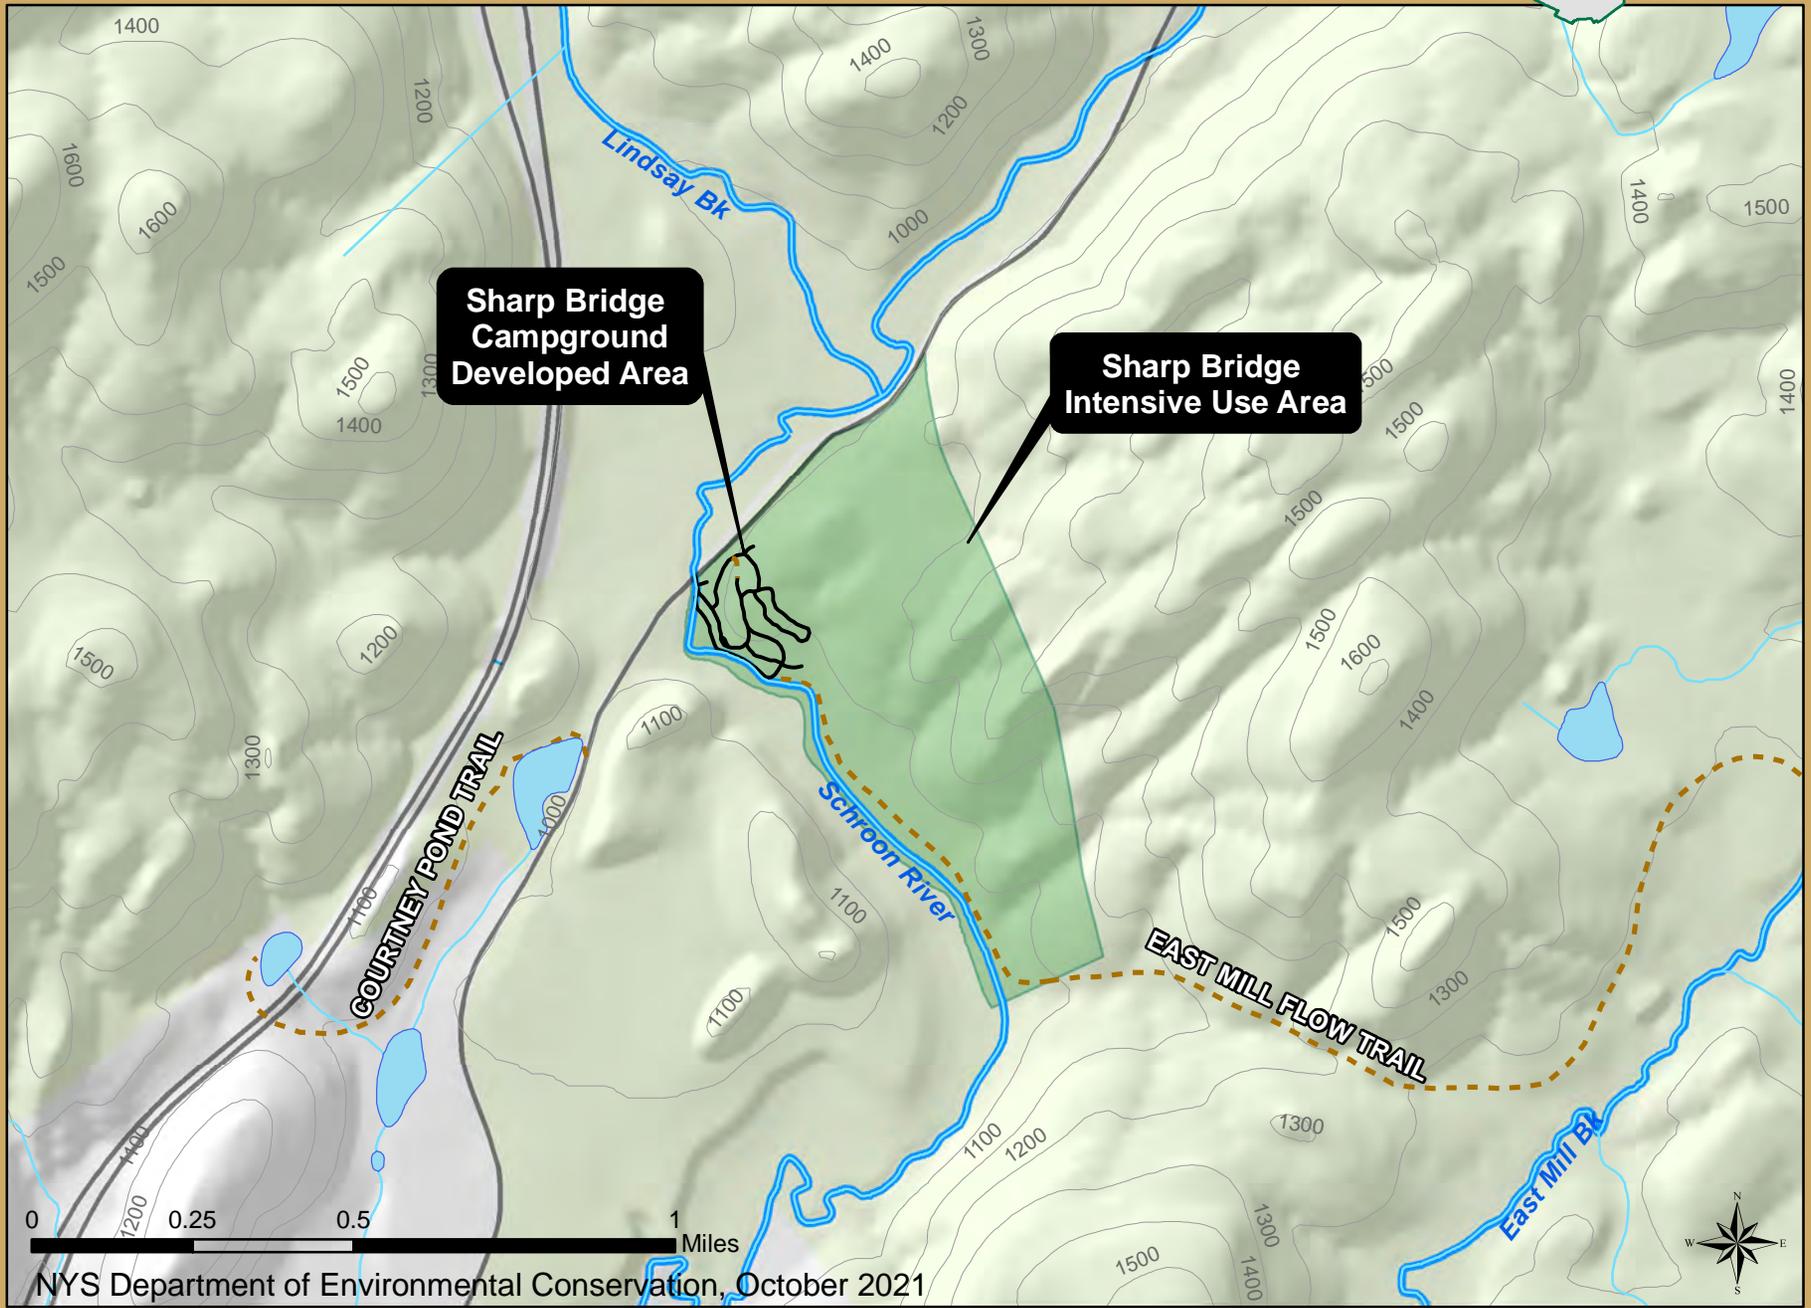
Exhibit # 2 - Topography and Trails Map

The average elevation of Sharp Bridge Campground is 980'. The terrain of the campground is made up of three natural shelves and can be defined as rolling hills. (See Exhibit #2.)

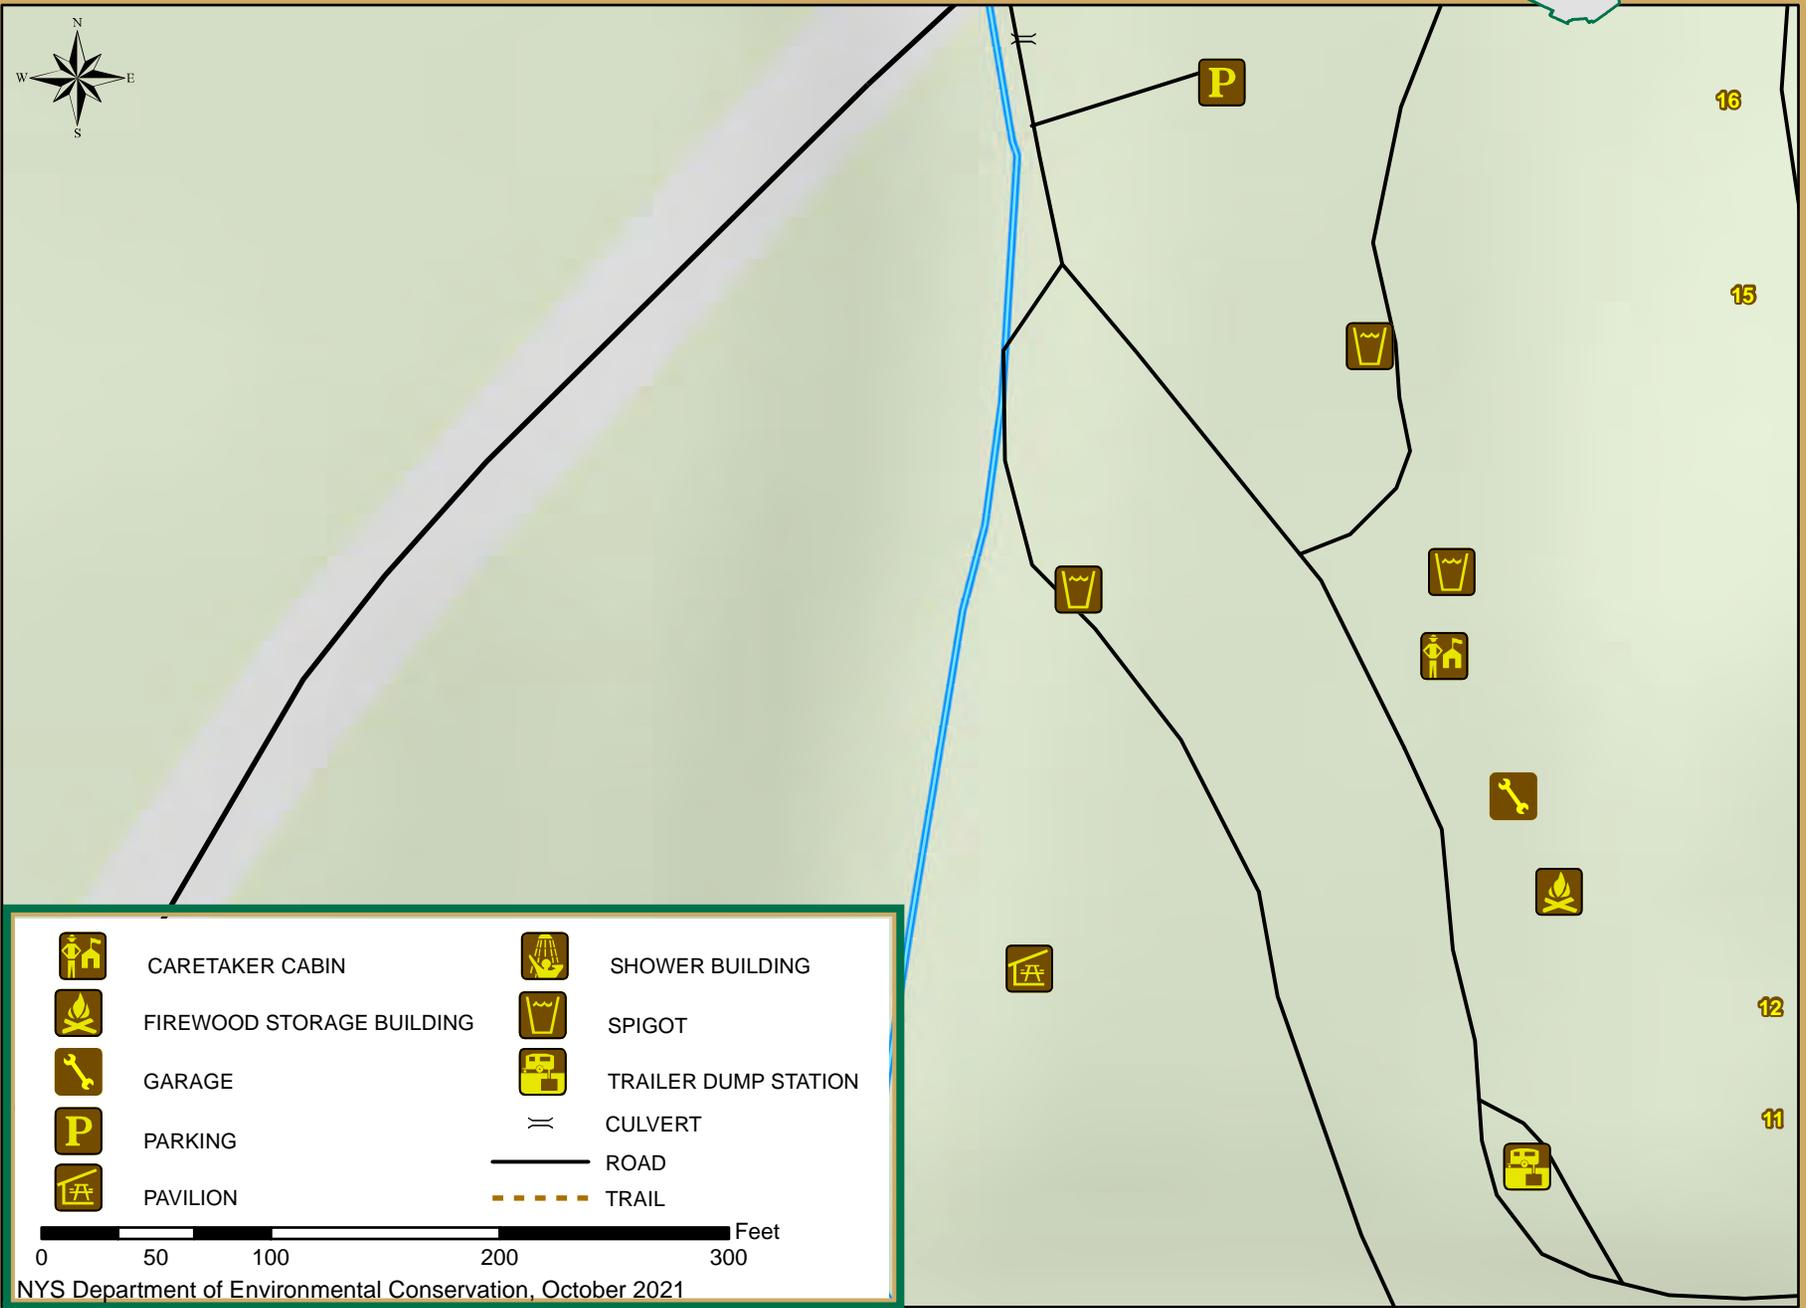
Exhibit # 4a - Facility Map of Entrance and Day-Use Area

CARETAKER CABIN		SHOWER BUILDING
	FIREWOOD STORAGE BUILDING		SPIGOT
	GARAGE		TRAILER DUMP STATION
	PARKING		CULVERT
	PAVILION		ROAD
			TRAIL

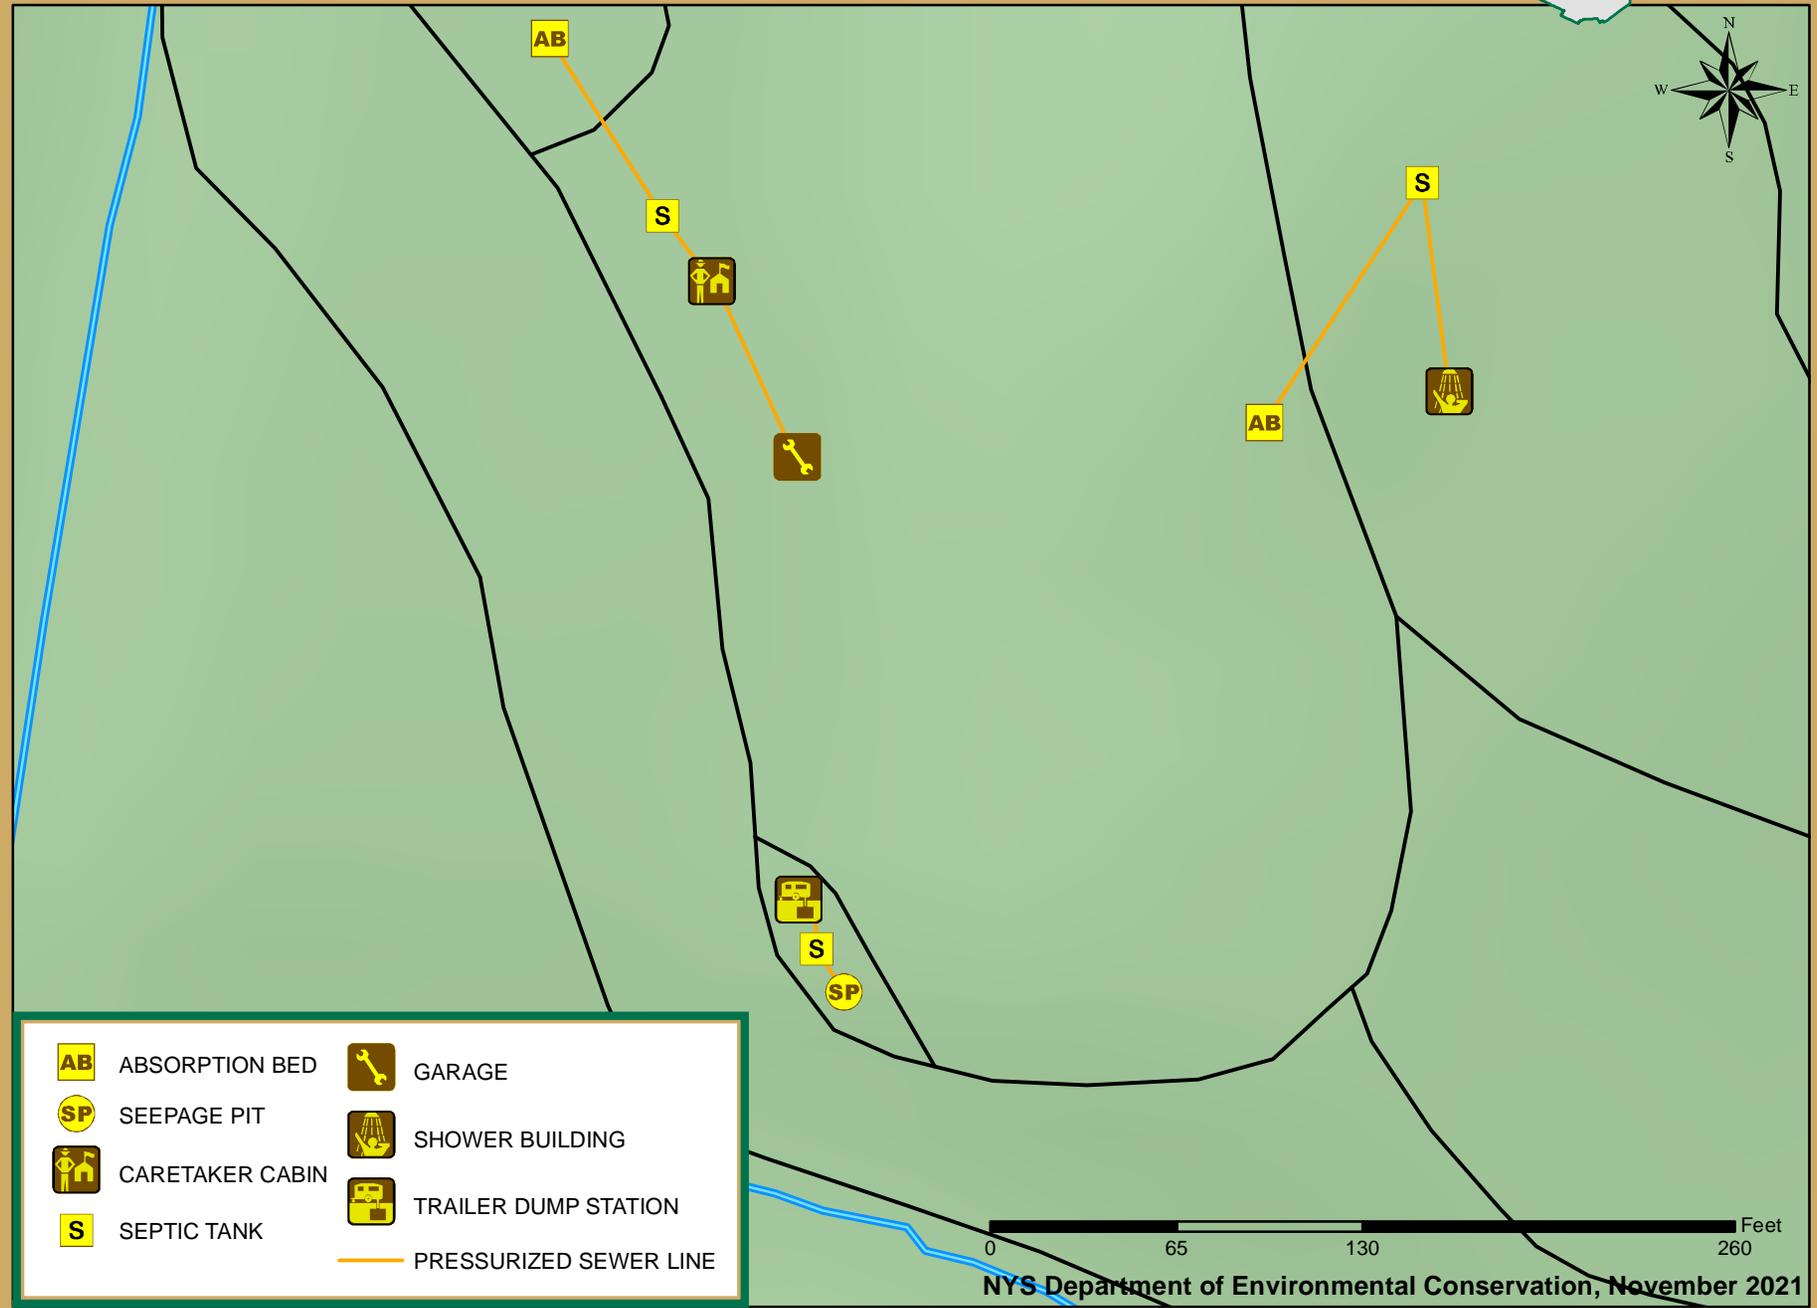
Exhibit # 5 - Sewer System Map

AB	ABSORPTION BED		GARAGE
SP	SEEPAGE PIT		SHOWER BUILDING
	CARETAKER CABIN		TRAILER DUMP STATION
S	SEPTIC TANK		PRESSURIZED SEWER LINE

All sewage disposal in the campground is by use of septic systems, utilizing septic tanks and absorption beds or seepage pits. There is 304 feet of gravity sewer line utilized as part of this system.

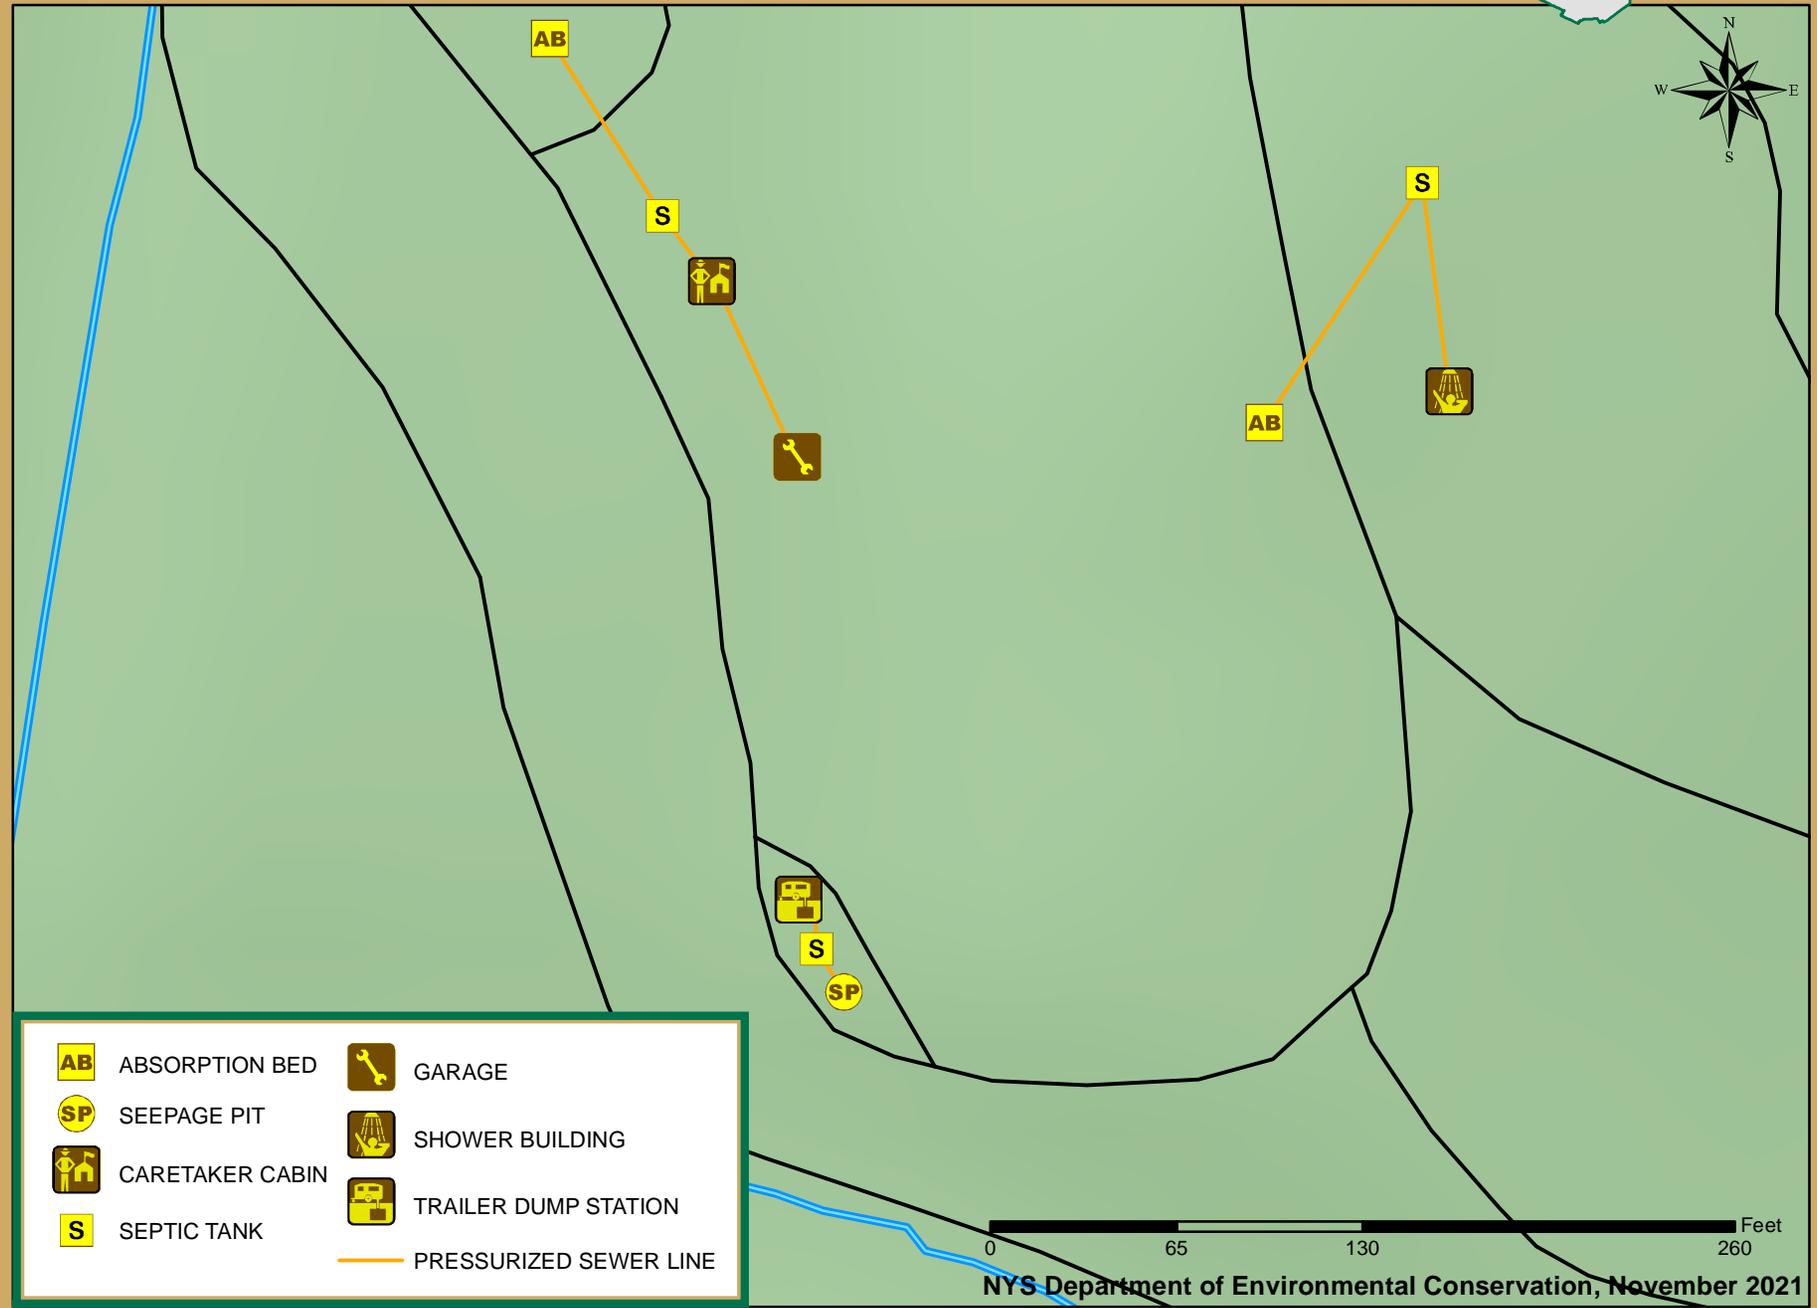
Exhibit # 5 - Sewer System Map

AB	ABSORPTION BED		GARAGE
SP	SEEPAGE PIT		SHOWER BUILDING
	CARETAKER CABIN		TRAILER DUMP STATION
S	SEPTIC TANK		PRESSURIZED SEWER LINE

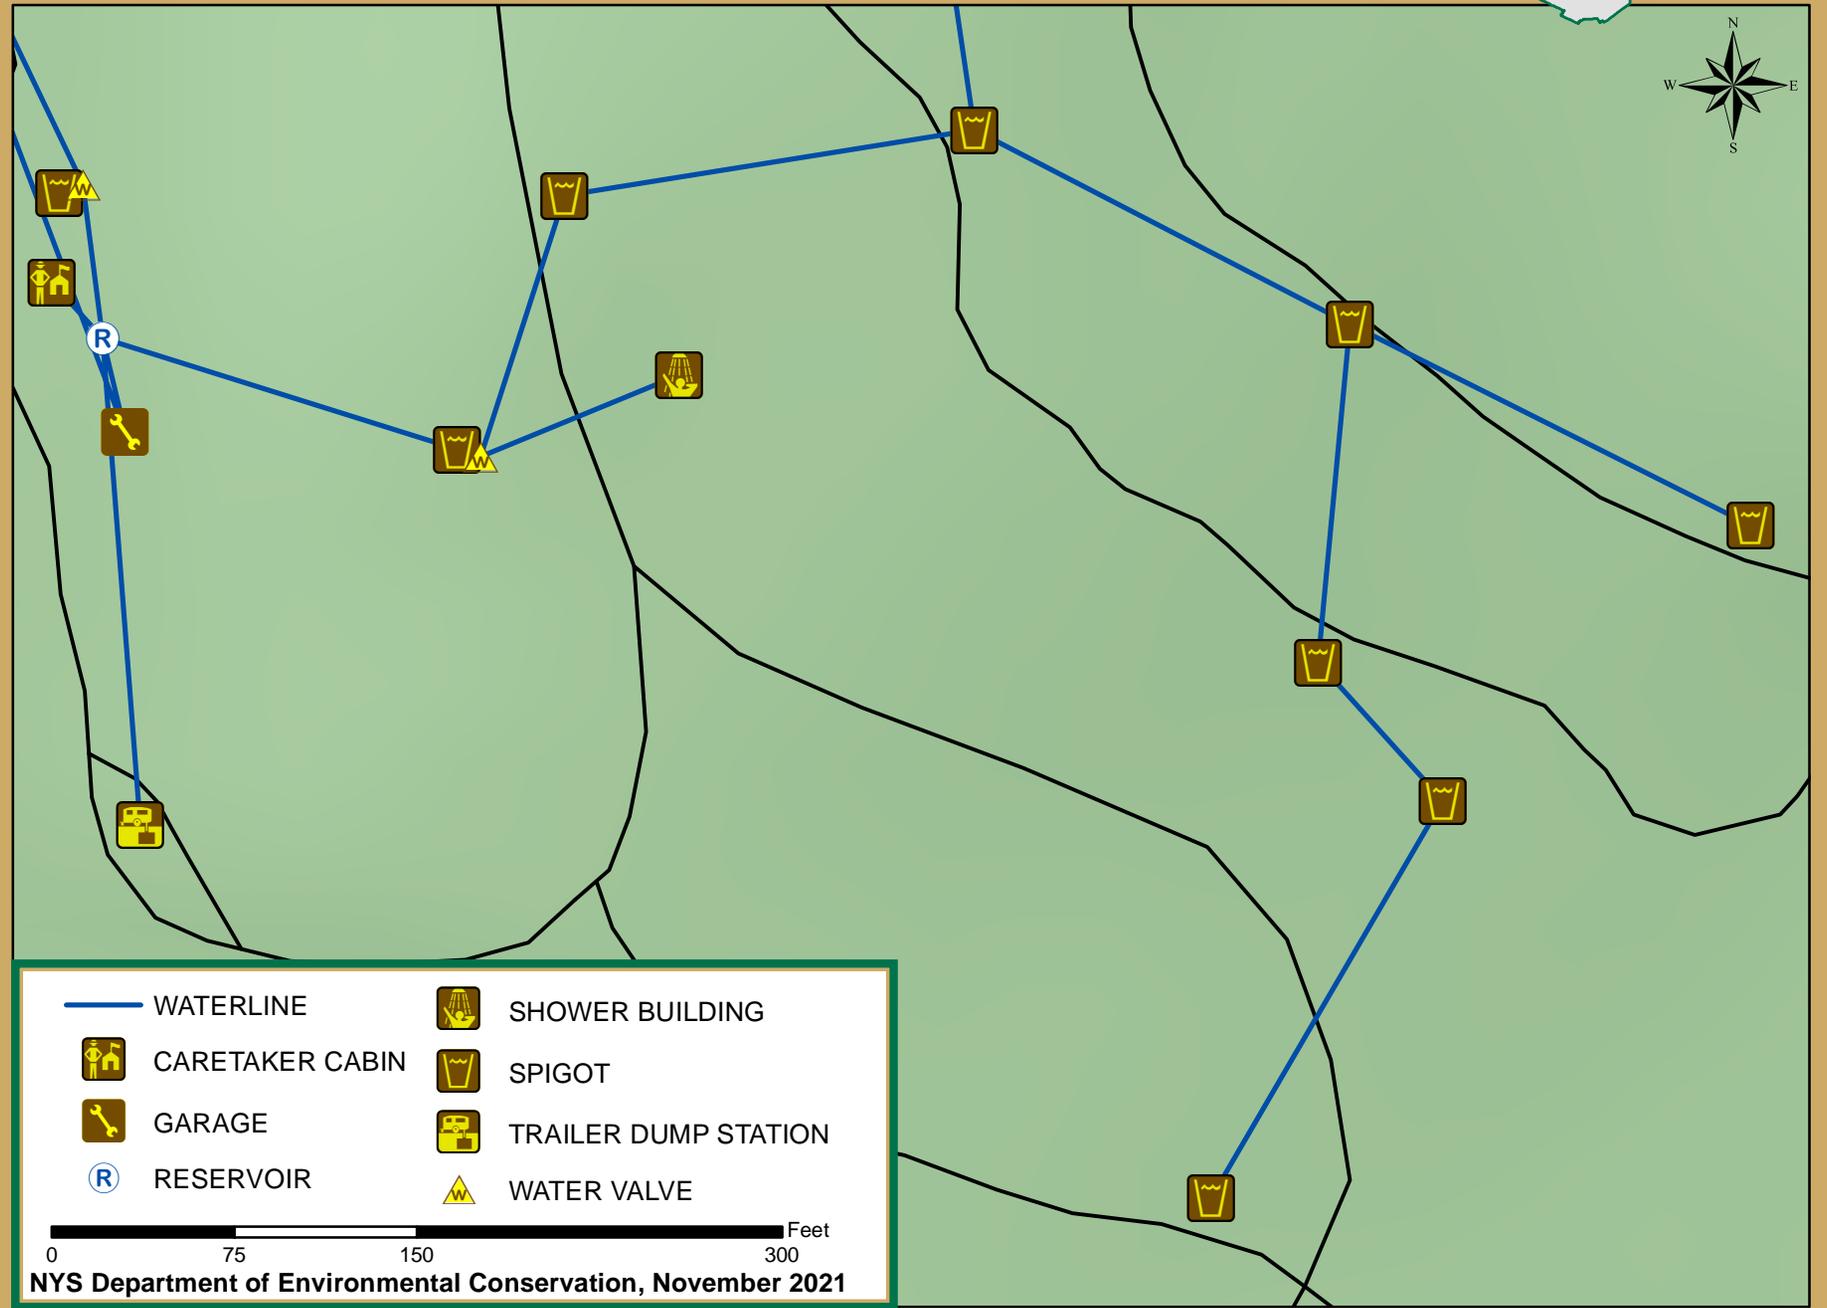
Exhibit # 6b- Water System Map

WATERLINE	SHOWER BUILDING
CARETAKER CABIN	SPIGOT
GARAGE	TRAILER DUMP STATION
RESERVOIR	WATER VALVE

Water is distributed to various buildings and 12 water spigots throughout the campground via 3,152 feet of buried waterlines. (See Exhibit #6a-b.)

The water system at Sharp Bridge is old and needs rehabilitation to meet current DOH regulations. The buried waterlines, tanks, and well should be replaced. Additional water spigots should be installed as necessary to meet health codes and accessibility standards. Tree and shrub replanting will be required to replace any vegetative loss due to clearing. This management action proposes to rehabilitate the existing water system to meet current design standards and Department of Health codes.

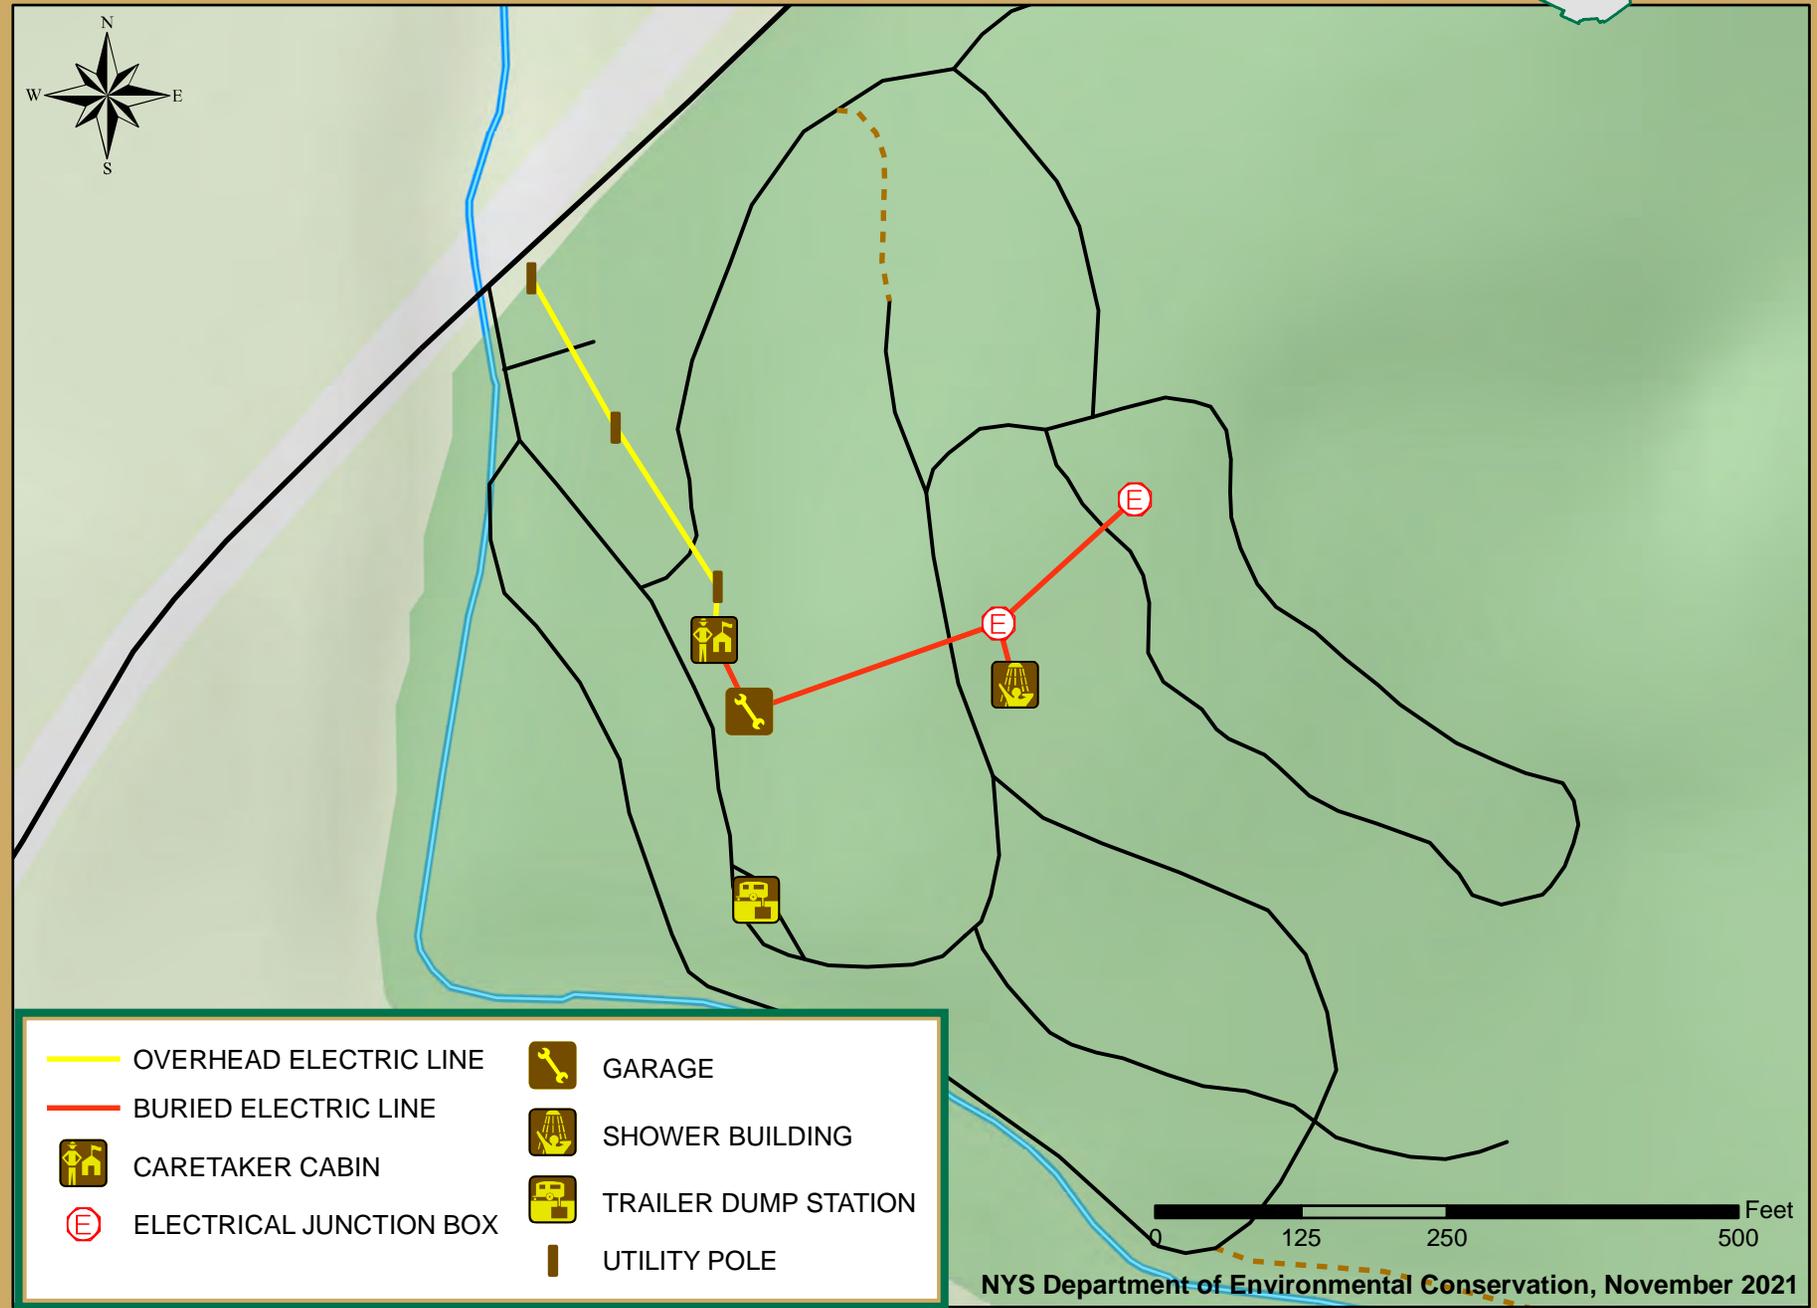
Exhibit # 7 - Electric System Map

OVERHEAD ELECTRIC LINE

The campground has overhead secondary electrical distribution from the entrance to the caretaker cabin. The remaining electric line is buried. National Grid Power Corporation provides electricity to the campground's electrical lines. Average annual electrical consumption is 10,375 kwh at a cost of \$1,460.

The electric lines within the campground total 861 feet and are owned by the Department. (See Exhibit #7.)

Sharp Bridge Campground has 861 feet of both overhead and buried power lines running through a facility that is heavily wooded in many locations. Both the water and sewer systems require electric power for pumps to operate. The 354 feet of overhead lines are in frequent need of maintenance. This management action proposes to bury the overhead power lines and to move the pole transformers to a ground pad location. Tree and shrub replanting will be required as part of this action to replace any vegetative loss. This action will improve system reliability, reduce maintenance cost and improve visual aesthetic of the area.

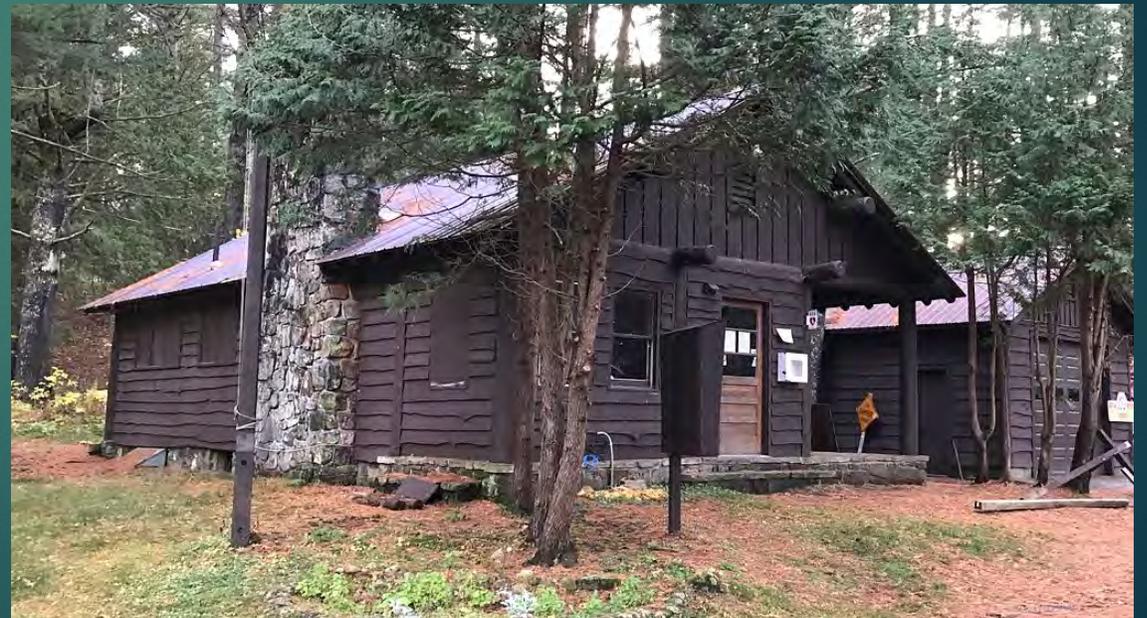
Caretaker Cabin and Office.

1. Replace Caretaker Cabin.

Sharp Bridge campground requires a staff of one, who is on premises 24 hours a day. There is currently one building available to house employees who live beyond a reasonable commute. The existing caretaker cabin was built in 1948 and is in fair condition. The building should be replaced to accommodate staff and their family, if required. This management action proposes to replace the building with a four-bedroom home in the same footprint and will meet all codes. This will also be available for larger facilities nearby to house staff. Siting will prioritize the use of existing disturbed areas to limit clearing of existing vegetation and minimizing topographic alterations.

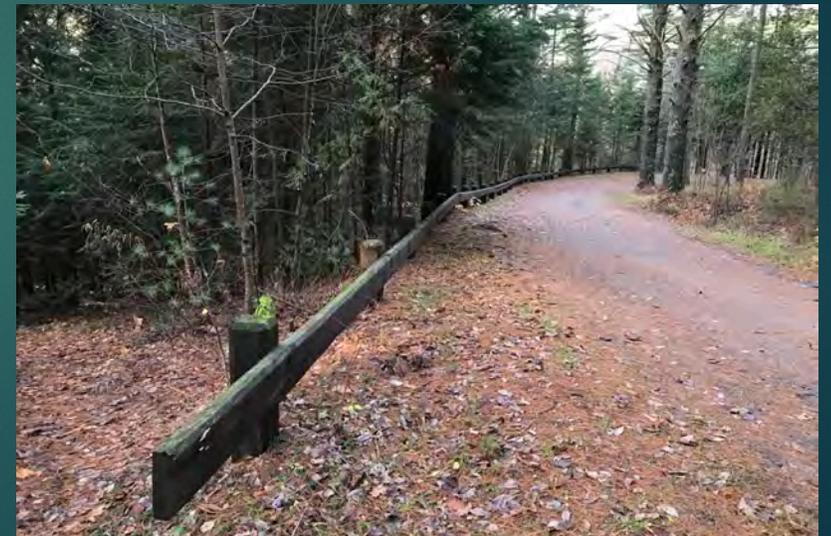
Paved Road with Guardrail into Camping Area.

The .90 mile of interior campground road is in poor condition with crumbling shoulders and potholes. The entire .90 mile of roadway needs to be repaved, while the additional .28 mile of campsite driveway and access roads should be maintained as gravel. Where possible, roads rehabilitation design should consider access for emergency response and maintenance vehicles. Based on current and anticipated visitor use, most of the campground would require a typical one-way road. The entrance road will be a typical main road, paved, and measure 916 feet. The road beyond the trailer dump station continuing to the shower building and the junction near campsite 20 would require a two-way road to safely accommodate campers. In addition to the main road, a total of 1,236 feet of paved two-way road

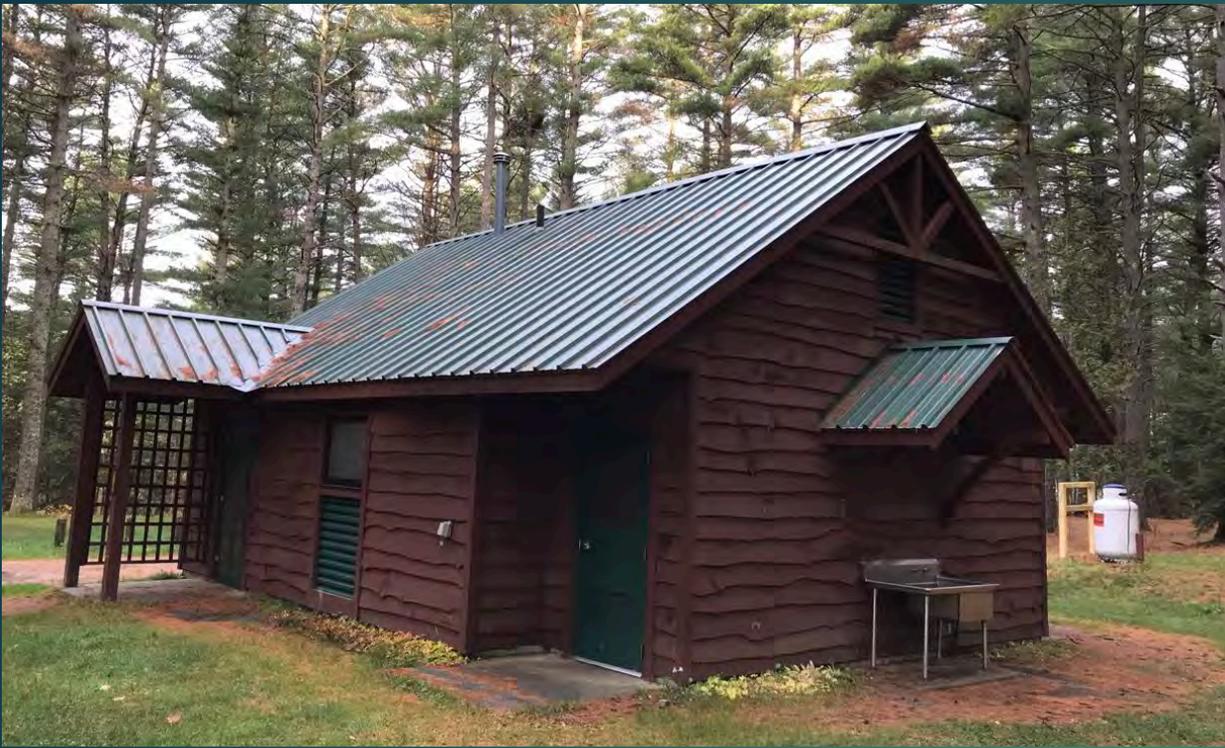
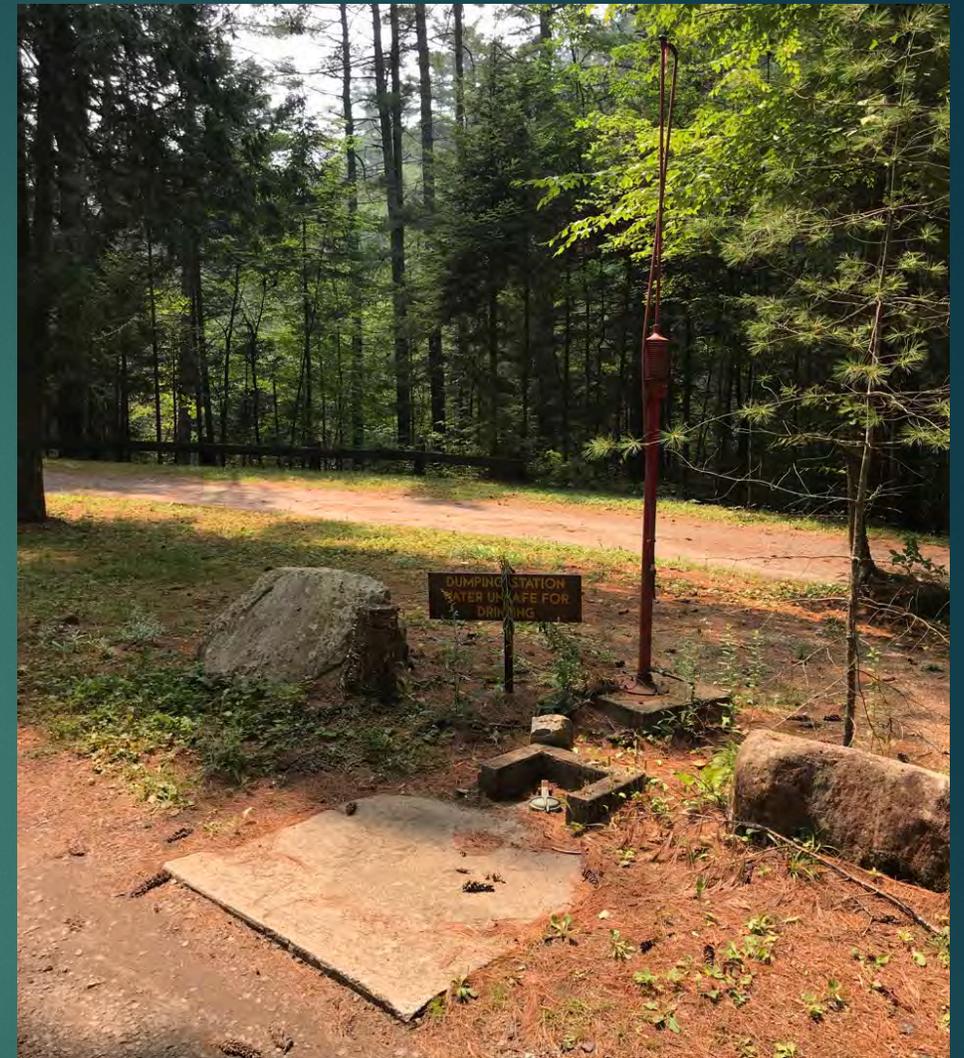
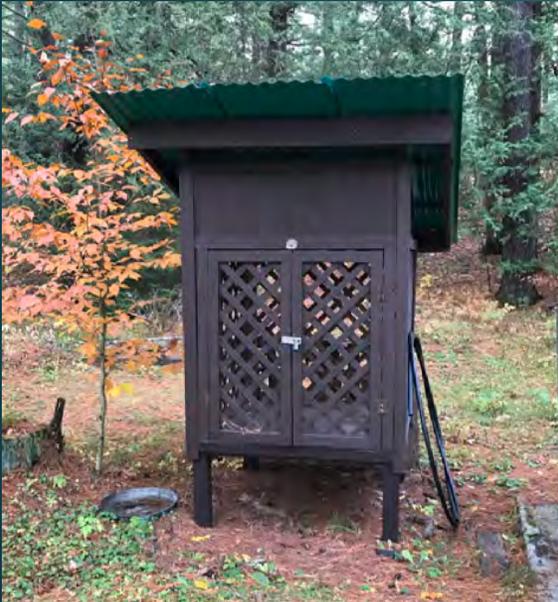
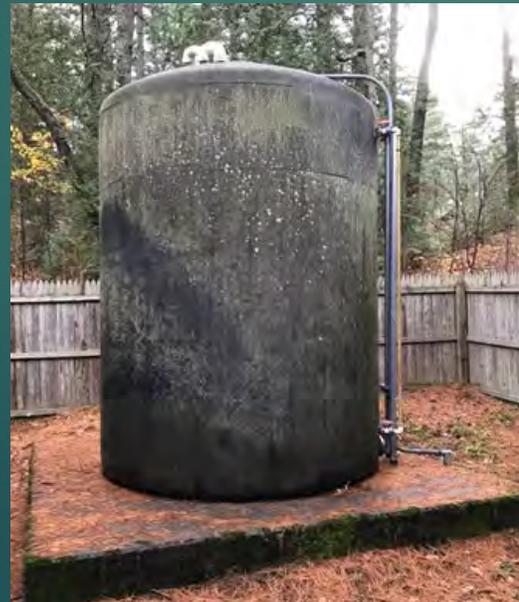
Photos (clockwise from top left): Shower Building, Trailer Dumping Station, Water Reservoir, Firewood Storage.

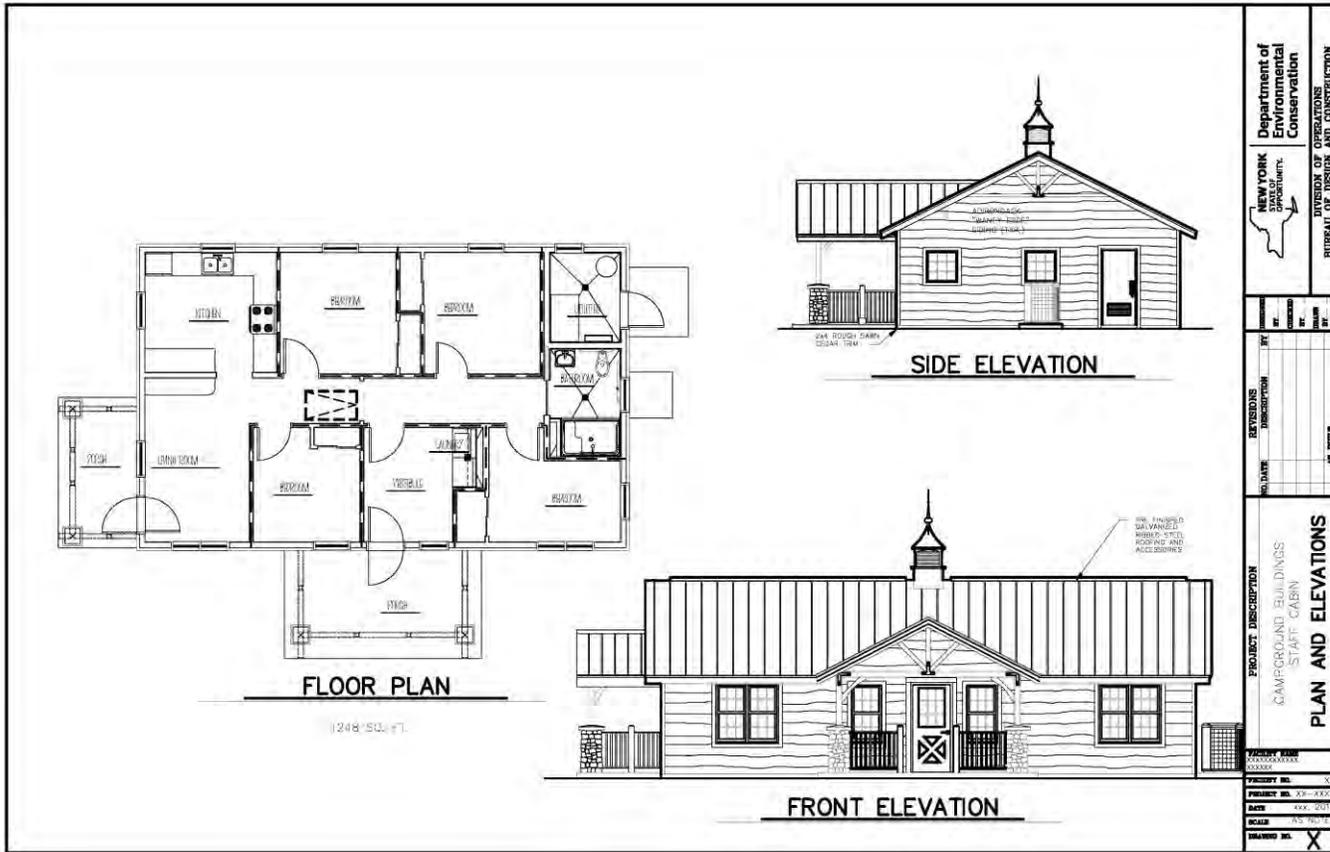
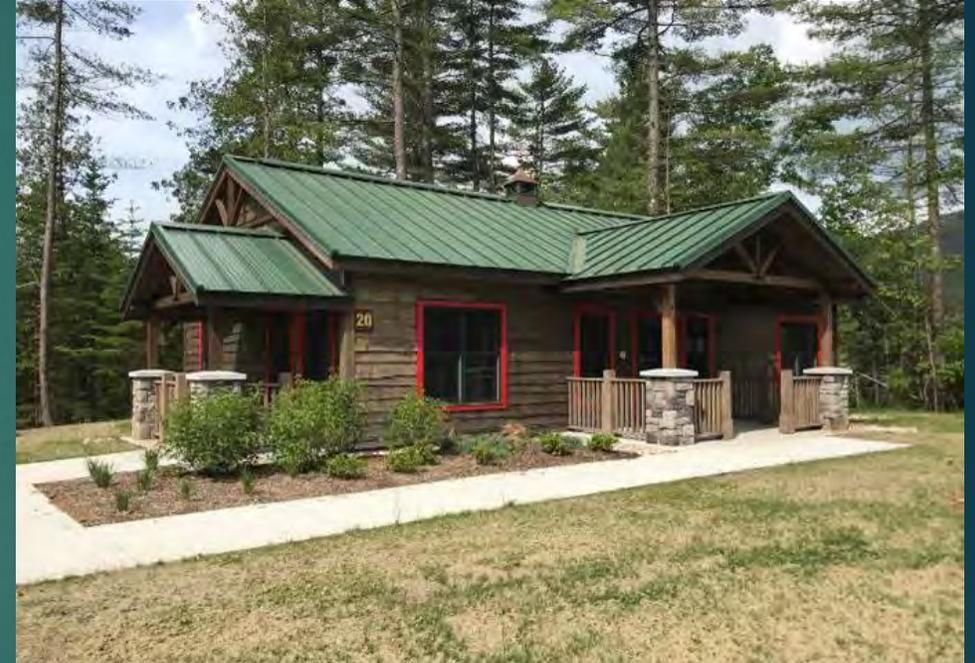
#15 Typical Drawings

Caretaker Cabin
